12.02.2018

Field work in Dolakha District

Assessment of landslide and slope
stability at 11 schools.

FORUT

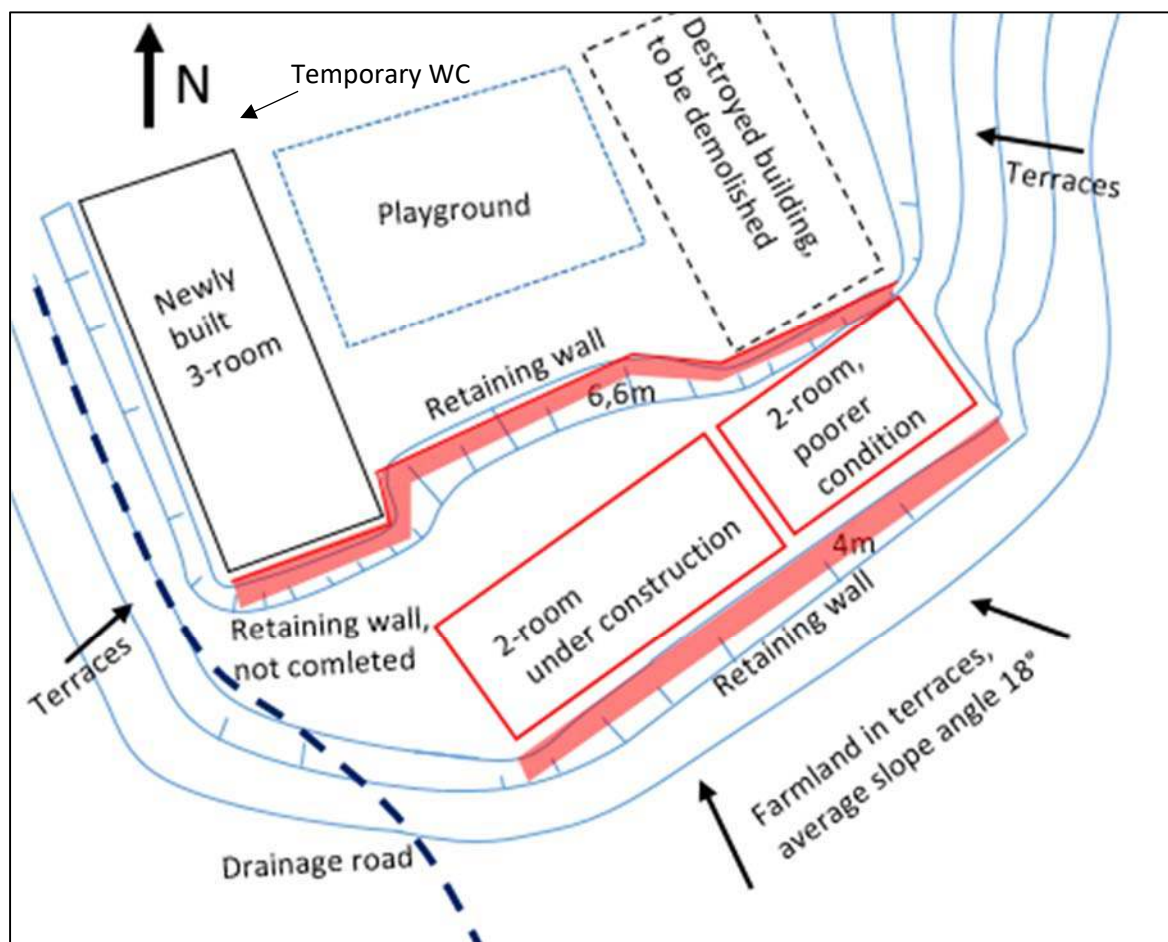
Figure 1-1 Plan view – Mahadesewori school. There is a height difference of 6,6 meters between the upper (southern) and the lower (northern) plateau. A retaining wall between the two plateaus should be constructed, also a railing for safety. The retaining wall close to the newly constructed 3-room building should be completed. Note: The drawing cannot be considered correct in terms of scale, it is based mainly on field observations.

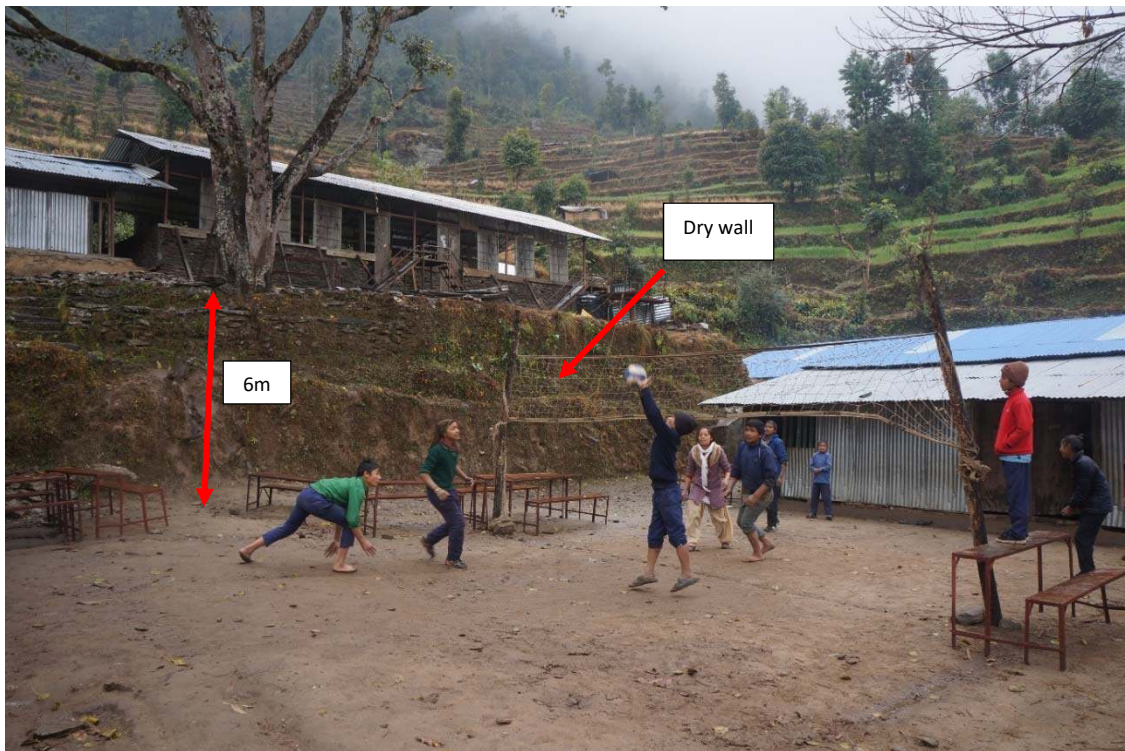
Figure 1-3 Schoolyard. The temporary shed will be removed. The building under construction is about 6 m above the schoolyard. The slope must be completed with a dry wall and stairs.

Stairs are missing from the bottom plateau to the upper buildings. This should be included. The path to the upper buildings is slippery, especially when wet.

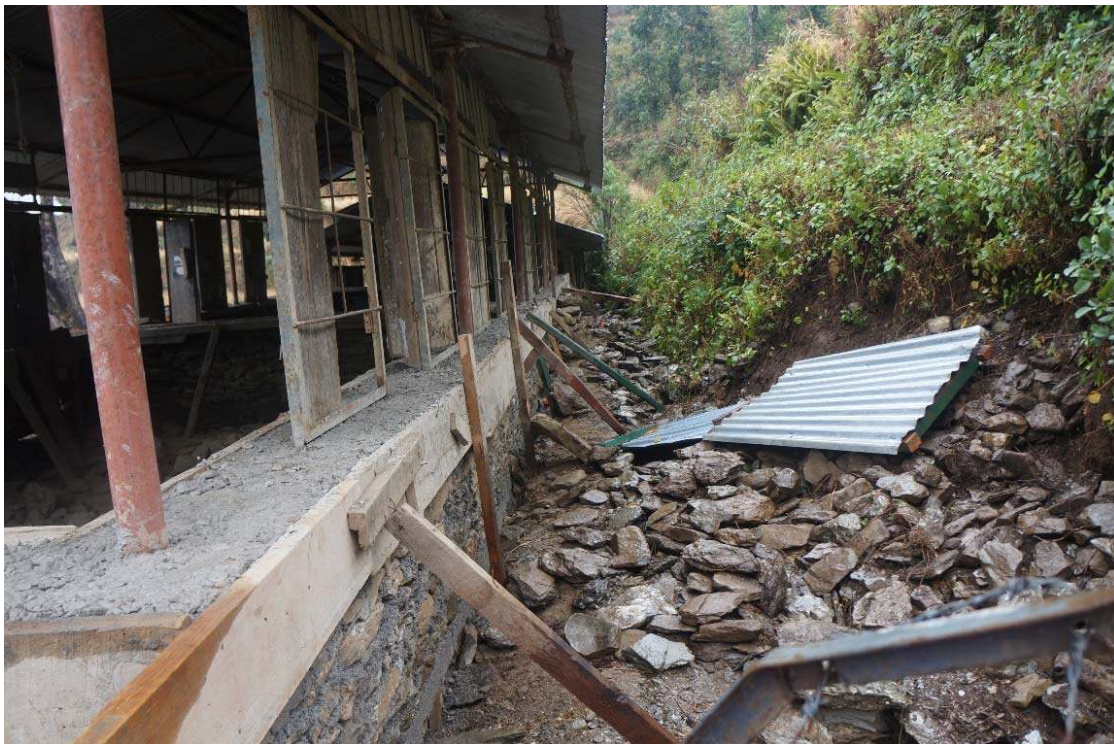
Figure 1-4 Movement of masses in the backslope. The slope should be secured by a reinforced wall.

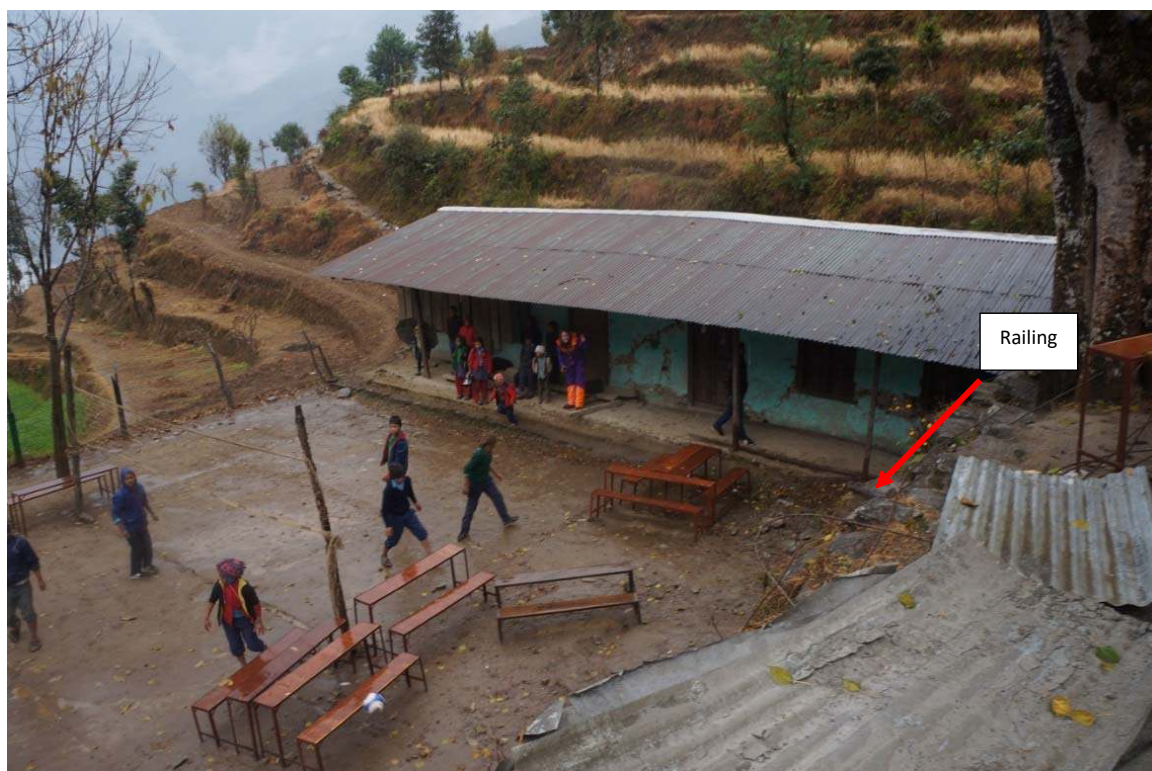
Figure 1-5 Schoolyard. View towards the damaged building. Railing should be constructed at the edge of the plateau.

At the plateau, railing is needed (Figure 1-5).

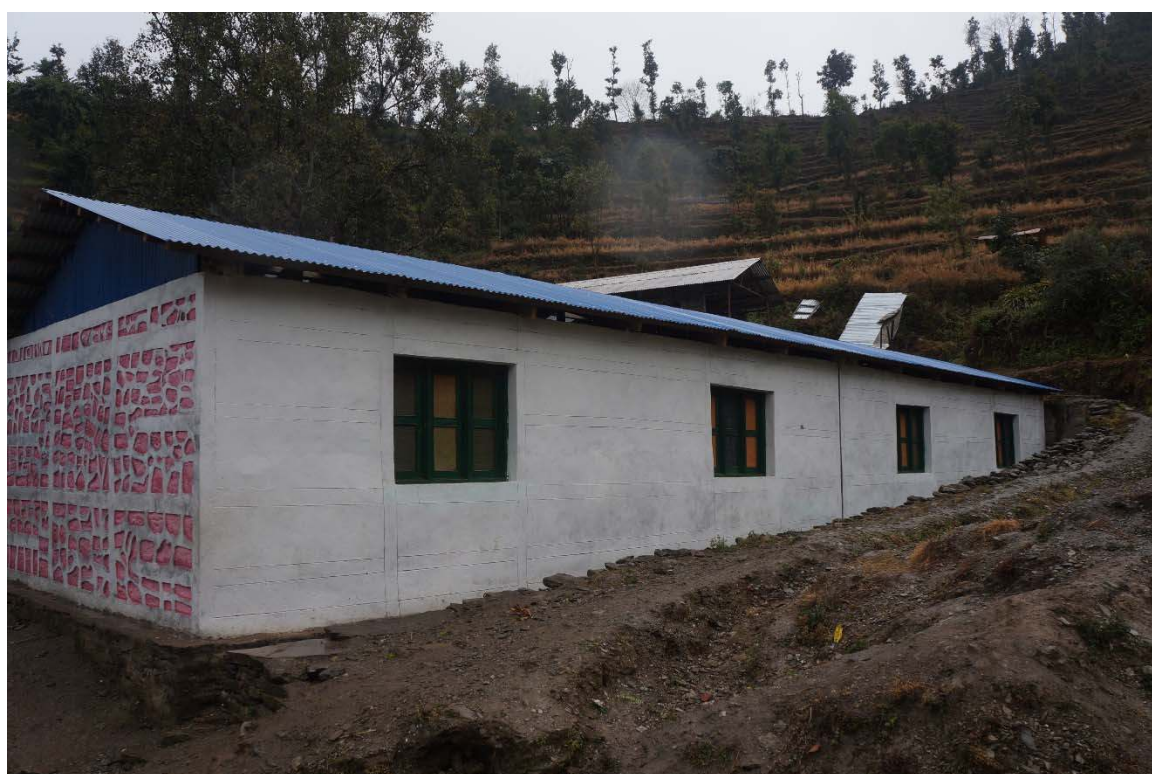
Figure 1-6 A small stream enter the school plot and is led around the new building. Drainage from the upper building should be linked to this drainage pattern. The flow path should be secured around the plot.

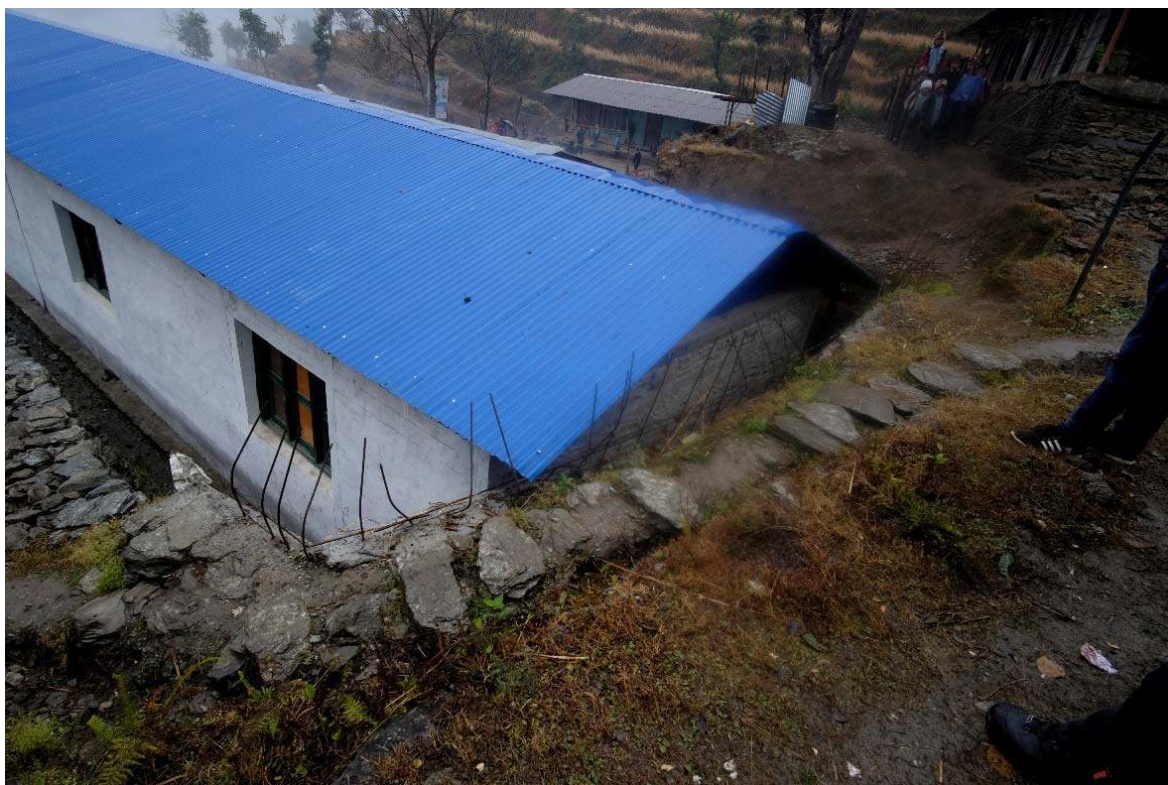
Newly constructed concreted retaining wall behind new school building is not finished. Exposed rebar provides a significant safety hazard.

Figure 1-7 Concrete wall (reinforced wall) is not completed.

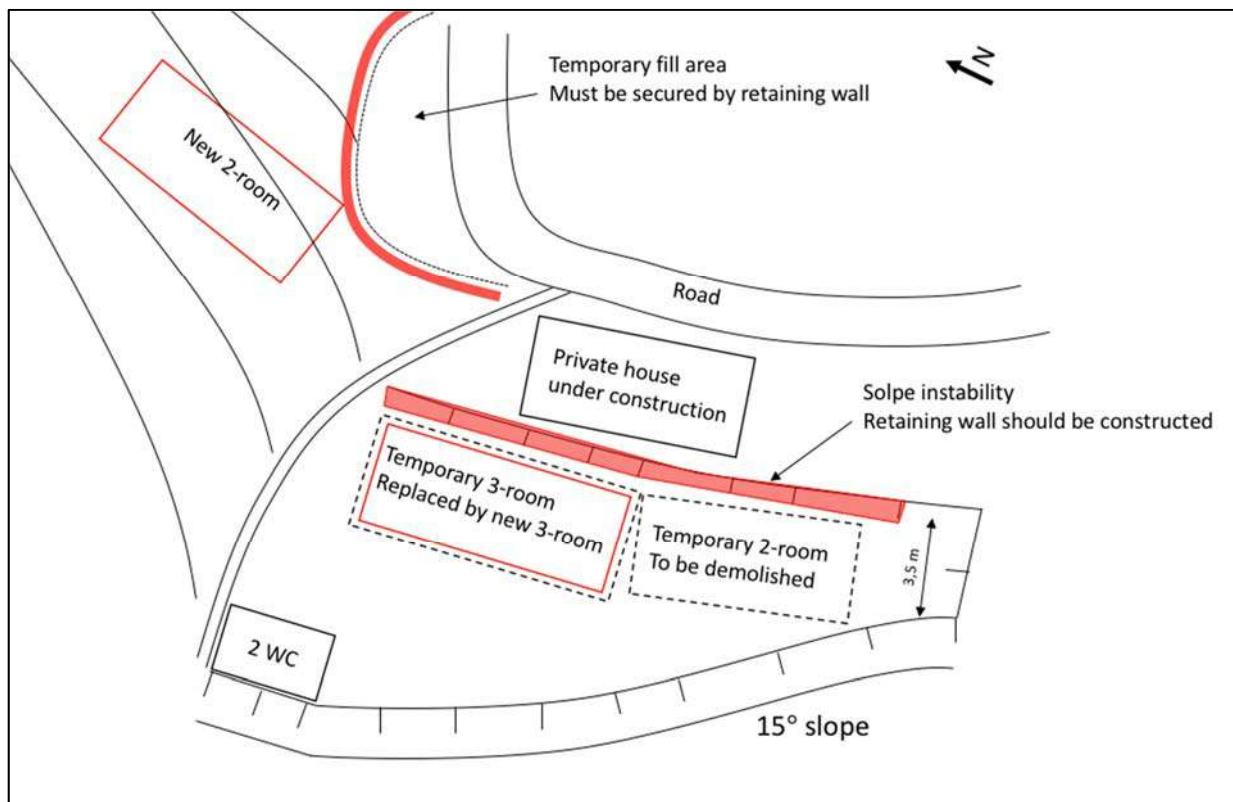
Figure 2-1 Plan view – Lingba school. Two retaining walls must be constructed; in front of the fill area and at the backwall.

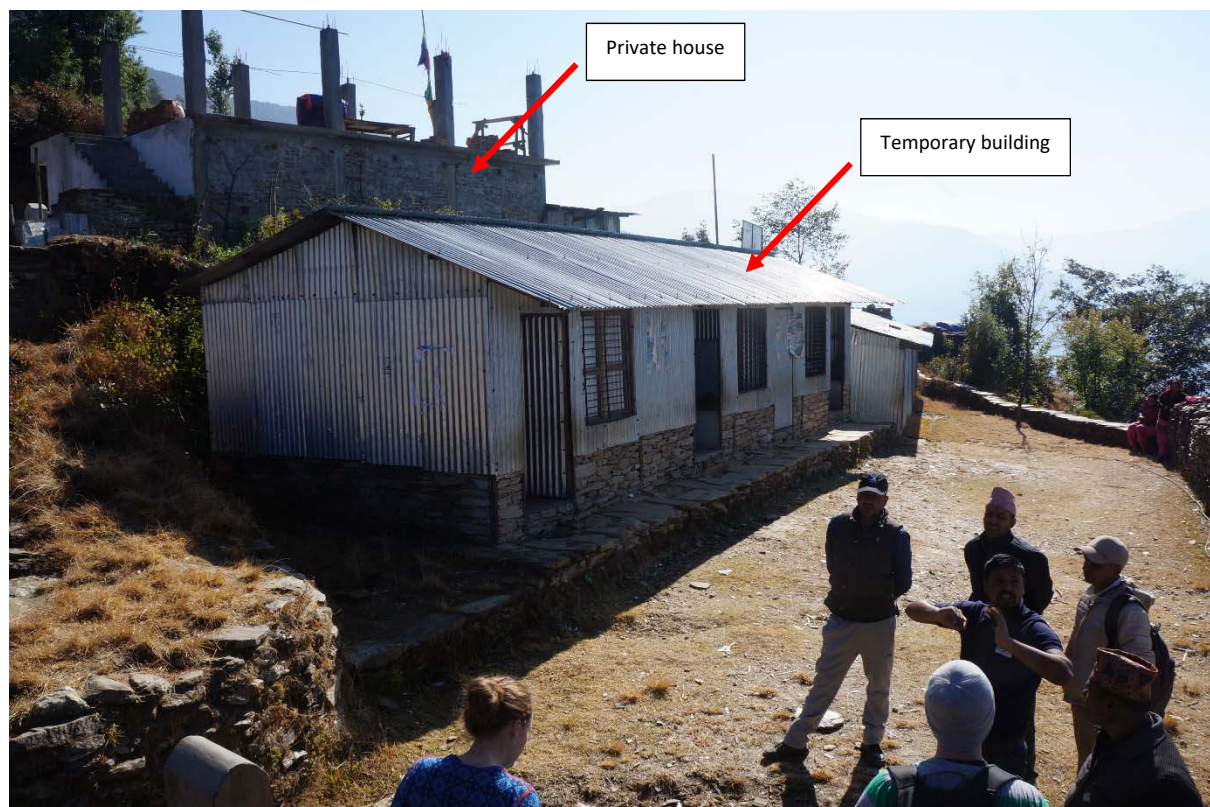
Figure 2-2 Lingba school, private house on a terrace close behind the school, two temporary buildings. A new building will be placed at the same location as the nearest one. Reinforcement of back-slope is necessary.

There should be constructed a retaining wall behind the existing school building before the construction of a new building in its place. Both to secure good light conditions, and for the local stability of the above terrace with a building.

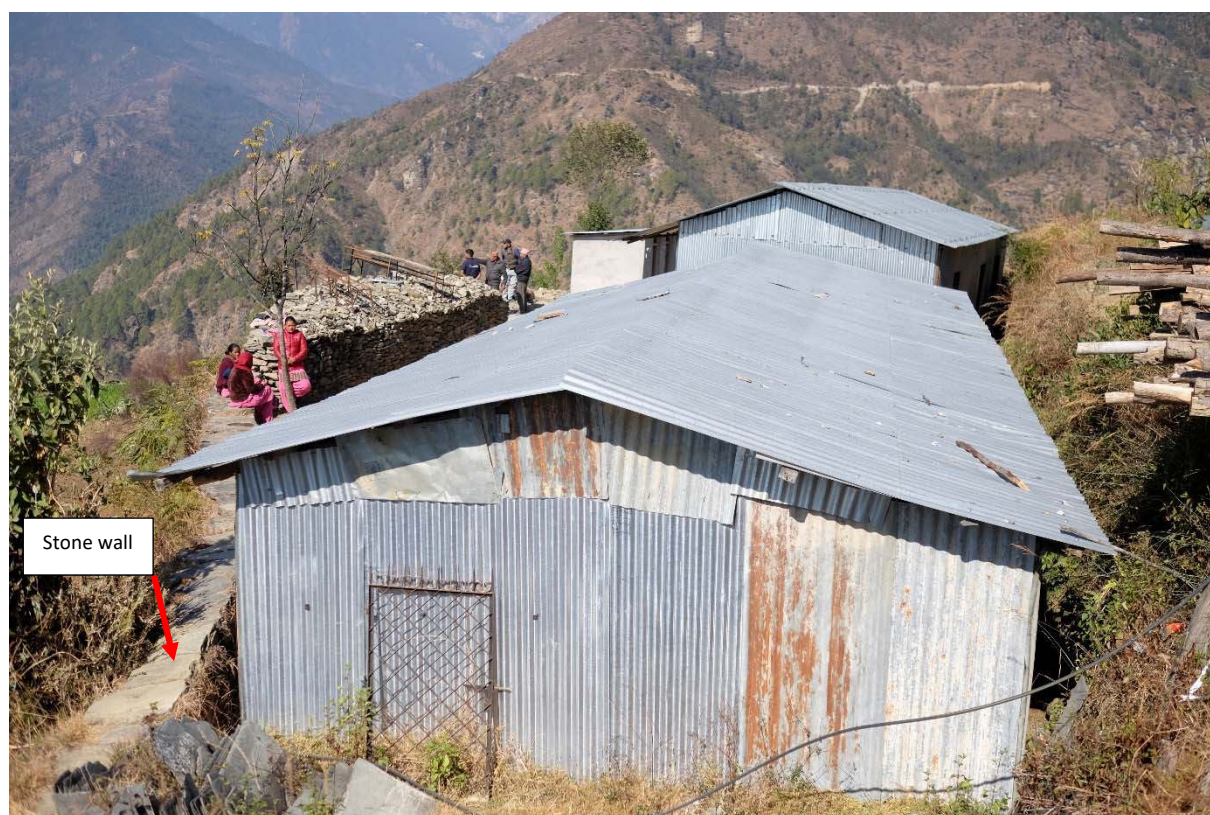
Figure 2-3 The plot is narrow at the eastern side. The stone wall at left side (downside) must be rebuilt in order to build the foundation.

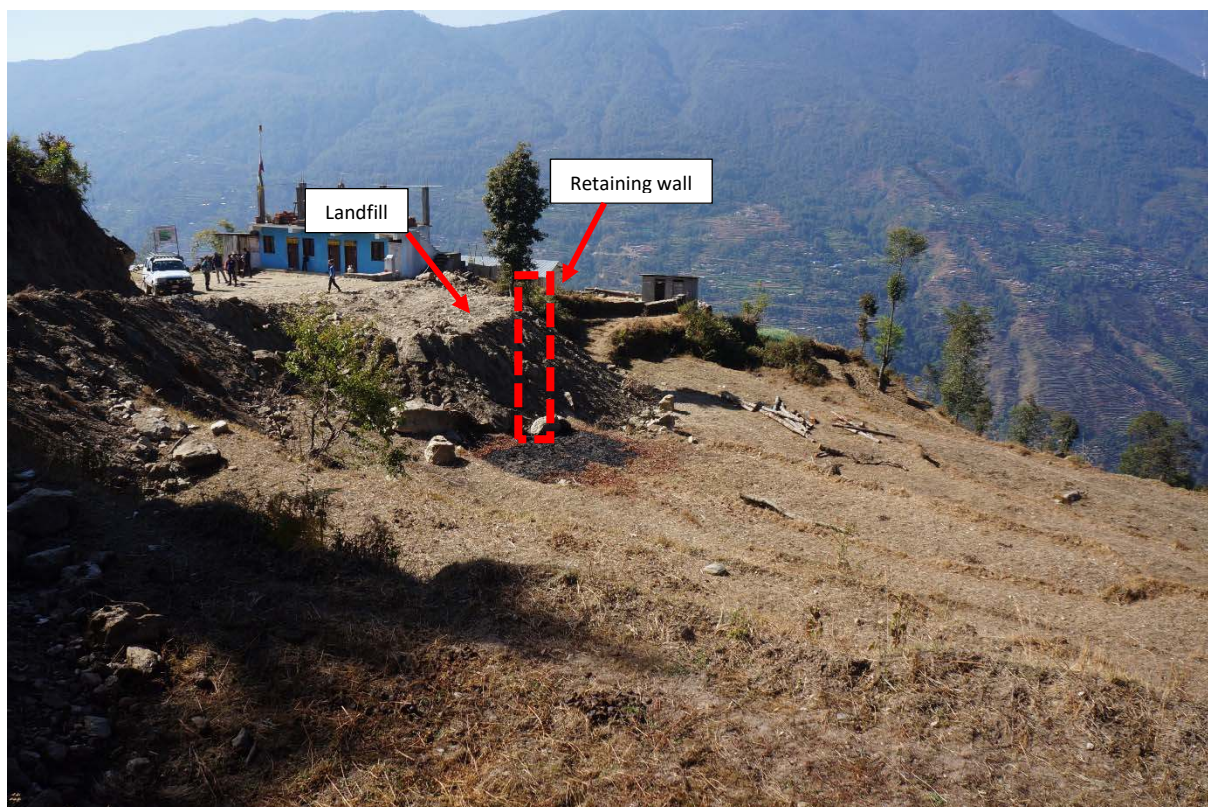
Figure 2-6 Alternative plot for the second building. It is close to the landfill and at present arable land. It is not advisable to move the new building against the slope. Land use planning and restriction of fill is needed in order to use this plot.

The site is quite narrow, and we don't recommend to place a building close to the wall, due to reduced light. Therefore, only one building should be placed at the existing school plot. Additional area north of the building is planned to be used for the 2-room building. This area is currently terraces with farmland. The 2-room building should be placed close to the road, see Figure 2-6.

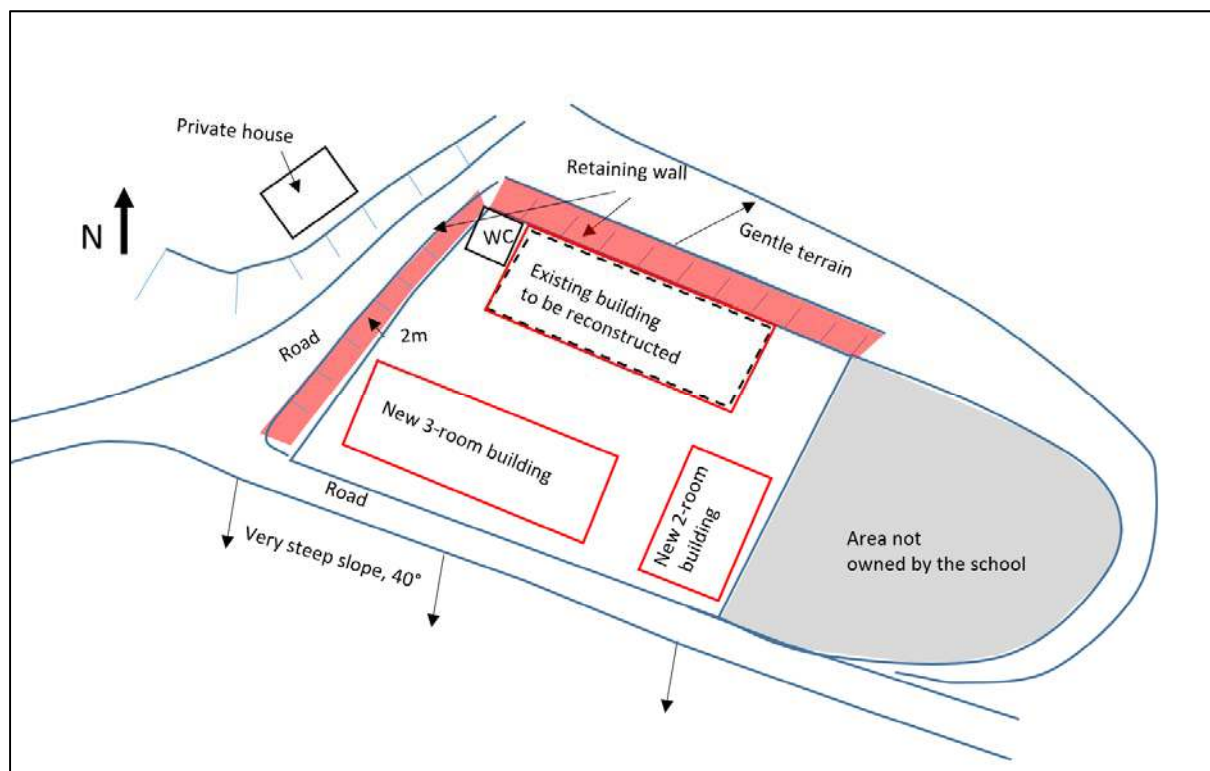
Figure 3-1 Plan view - Gyalsung school. Big flat plot. Retaining walls should be constructed in north-west to stabilize the road, and in north to stabilize existing building. The position of the 2-room is proposed either in east, as in the figure, or in west of the plot.

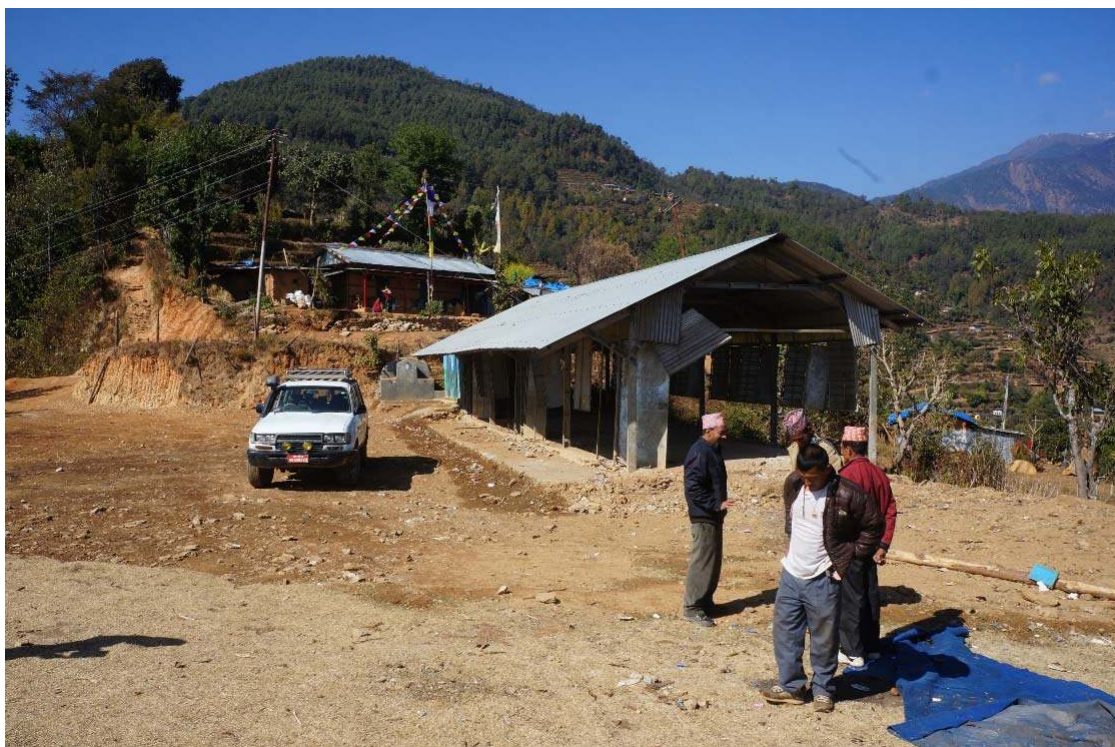
Figure 3-3 Rest of existing building. The roof will be reused, but the foundation has to be new.

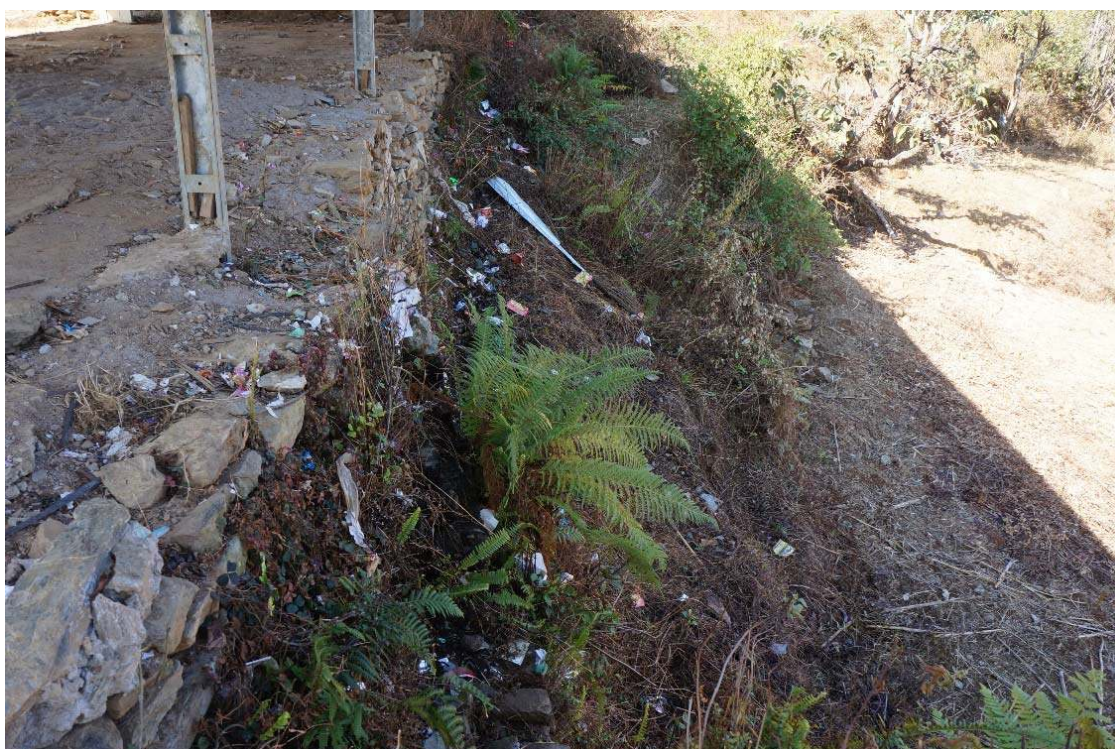
There is a damaged retaining wall north of the plot, which has resulted in settlement in the damaged building. This should be repaired upon reconstruction. If the 2-room building is constructed close to the road, a retaining wall should be constructed to stabilize the slope and ensure good light conditions.

Figure 3-4 The stone wall or gabion wall has to be rebuilt together with the foundation of a new building.

The retaining wall in the north part of the plot is damaged, causing settlements in existing building. This should be repaired upon reconstruction of the existing school to prevent further settlement damage.

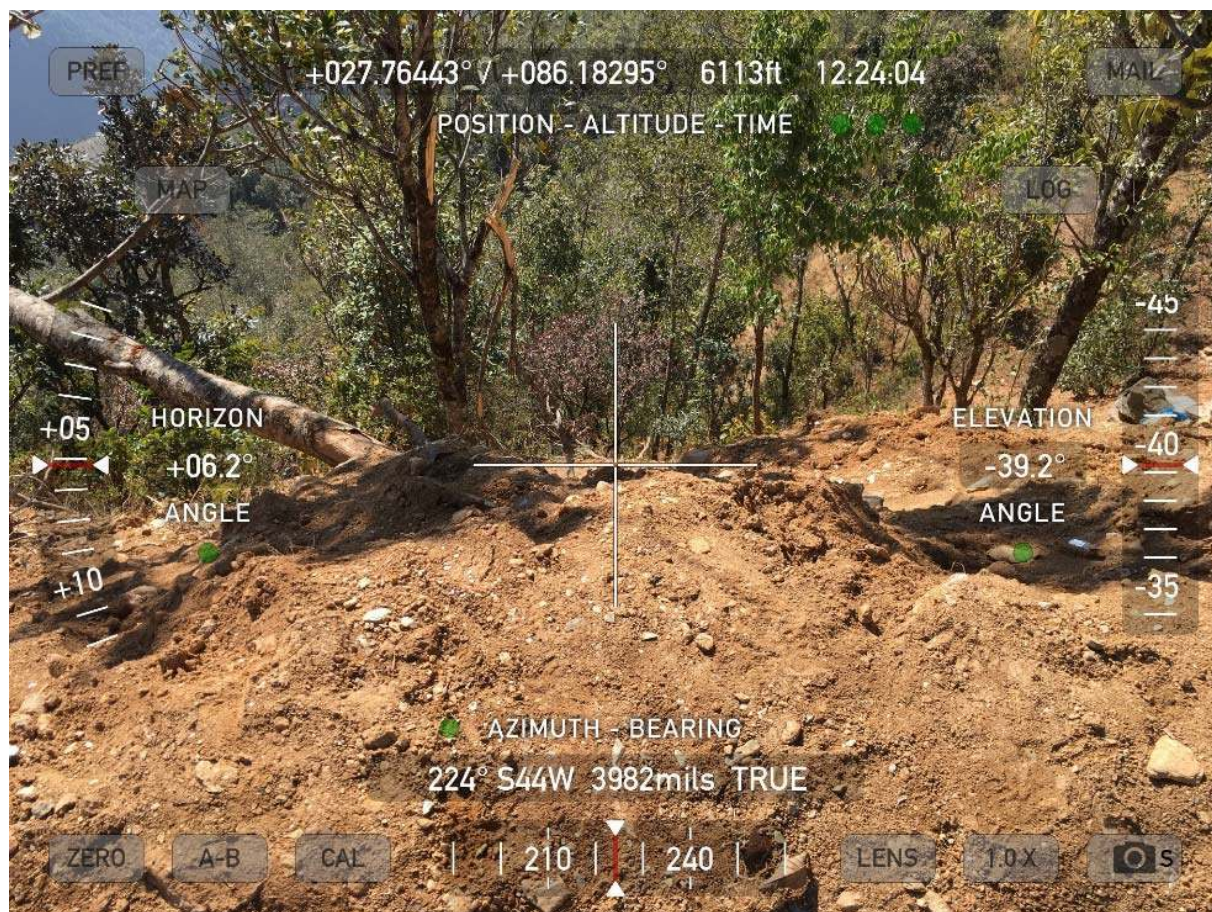
Figure 3-7 Slope angle below the new road (or newly enlarged road) ~40°.

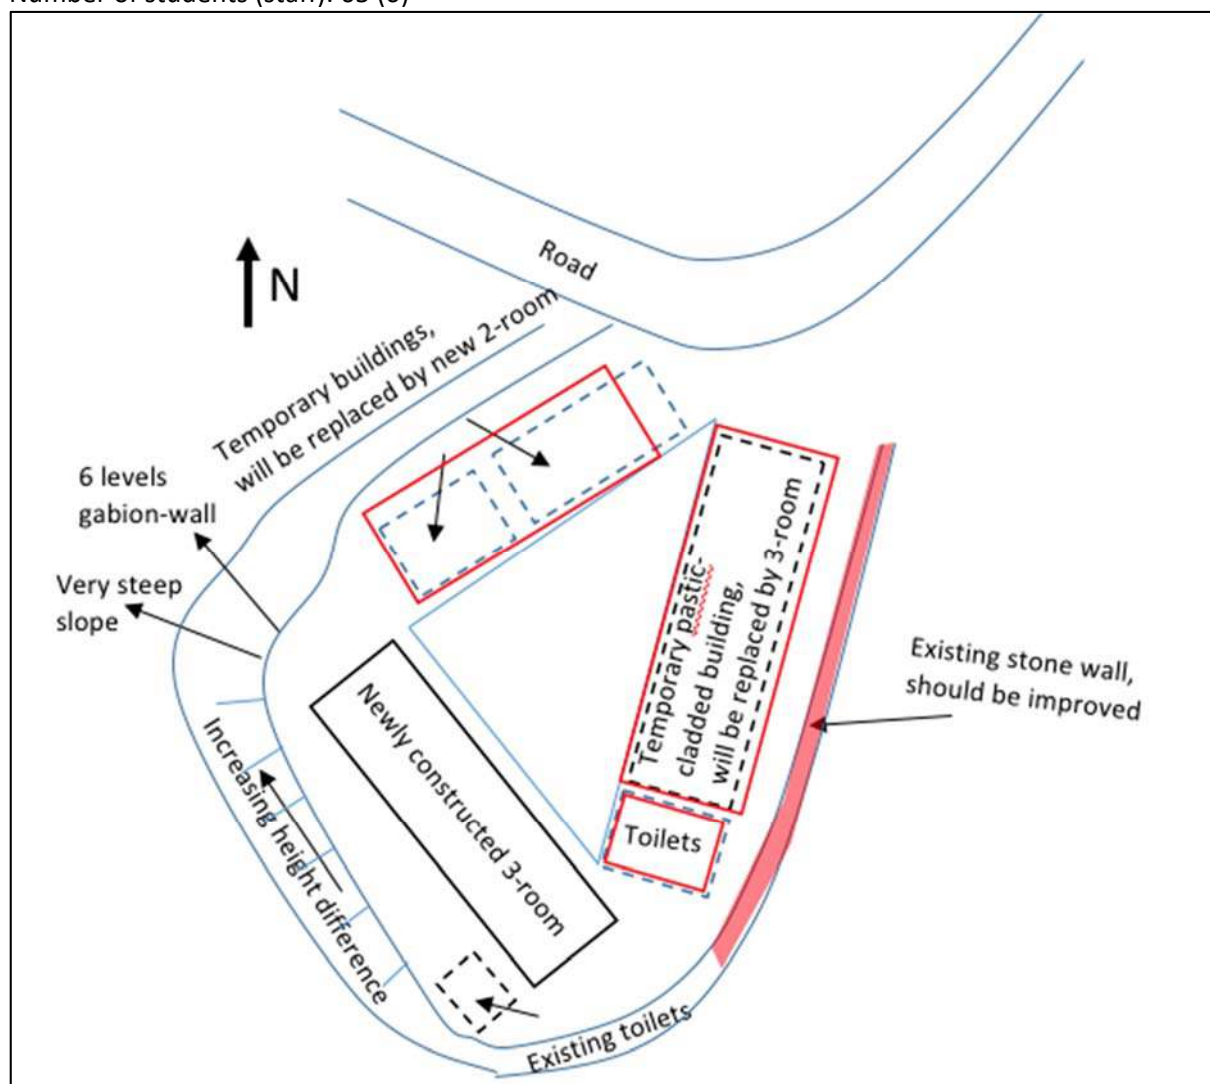
Figure 4-1 Plan view – Narayani. A retaining wall should be constructed on the east side of the plot. The foundation of the new 2- room building may require a dry stone wall at the border of the school plot.

A retaining wall should be constructed on the east side of the plot. This should be in place before the foundation work of the new 3-room is started, to prevent damaging settlements.

The foundation of the new 2-room building may require a dry stone wall at the boundary of the school plot.

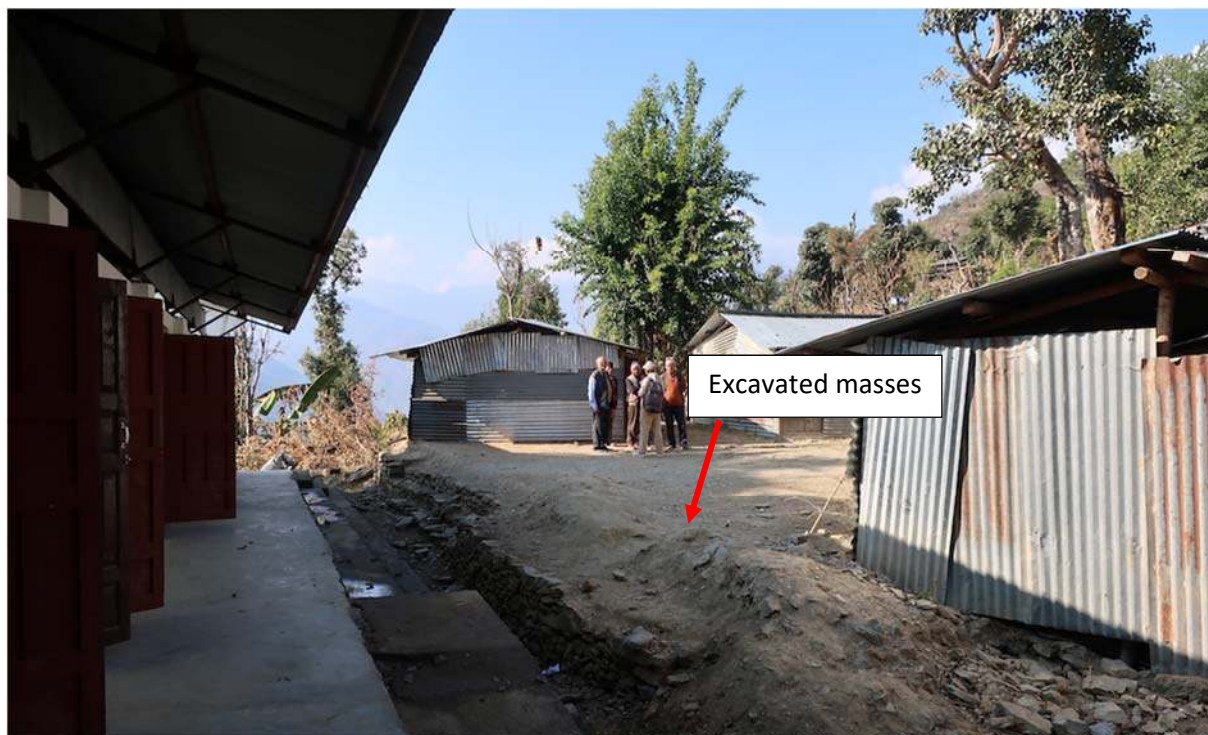
Figure 4-2 Narayani school. New 3-room to the left. The excavated masses in front of the new 3-room building and the schoolyard should be removed.

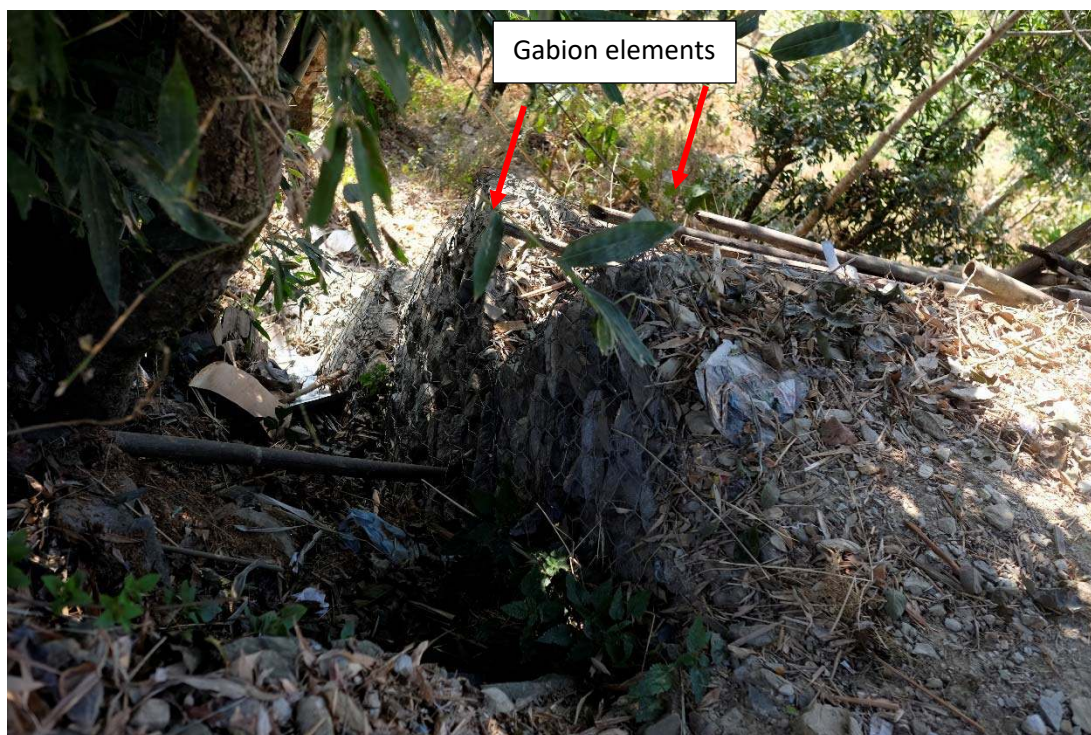
Figure 4-7 Four-five gabion-levels in new wall at SW corner of the new building. Railing should be considered.

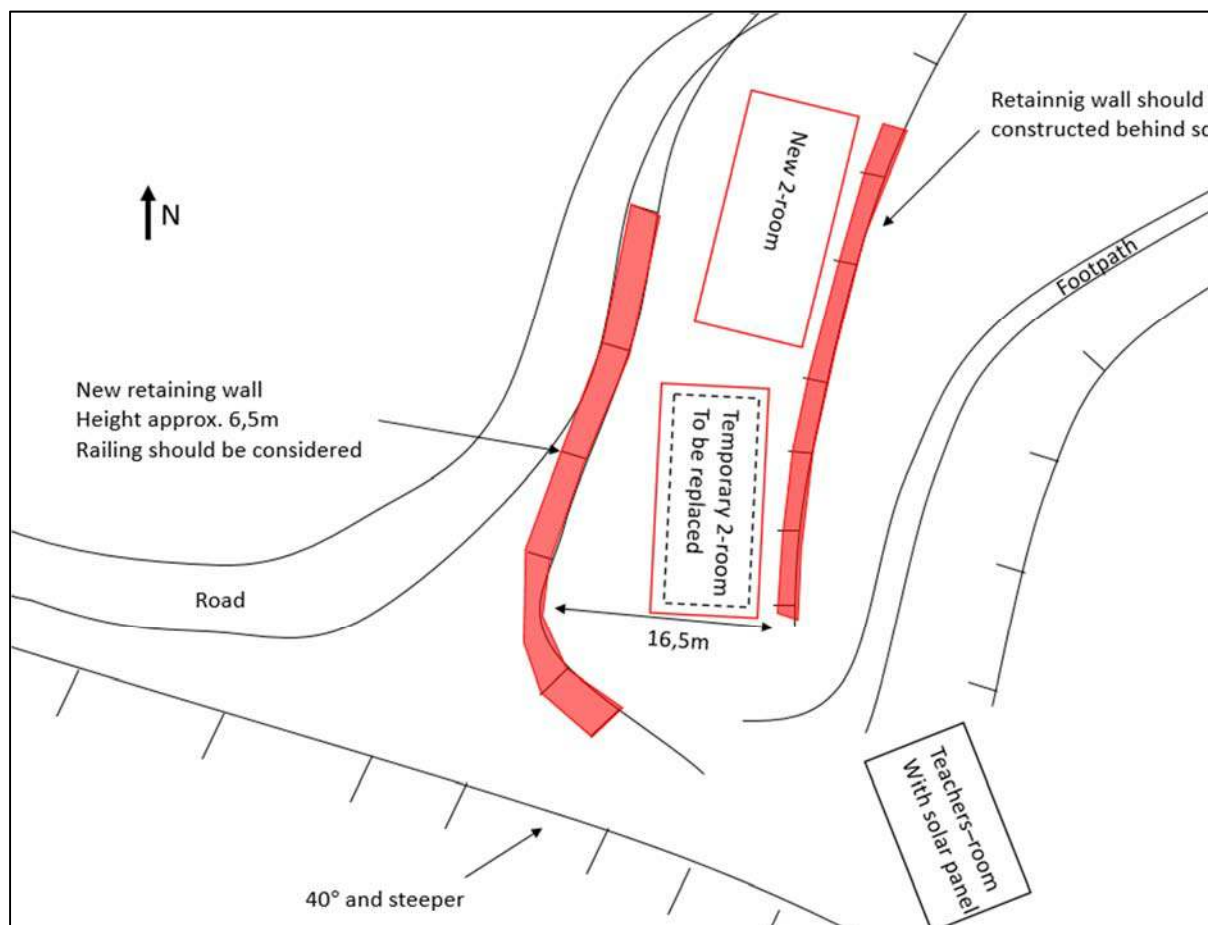
Figure 5-1 Plan view - Kaileswori. The new buildings should not be placed any further south than the existing temporary building because of the very steep slope. A retaining wall should be constructed between the road and school plot (west). A retaining wall should be constructed on the east side of the new school buildings, to improve local stability and ensure good light conditions.

A retaining wall should be constructed on the east side of the new school buildings, to improve local stability and ensure good light conditions

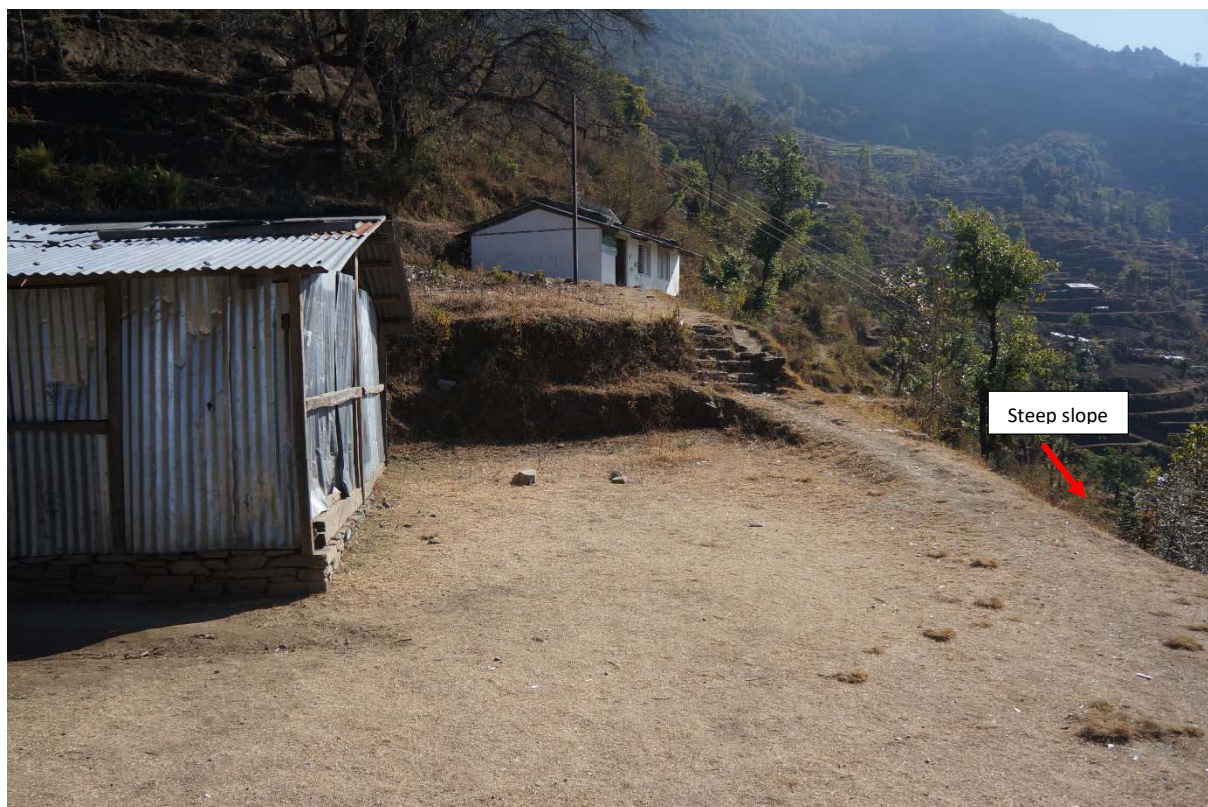
Figure 5-3 The new building should not be placed any closer to the slope. Staff building behind.

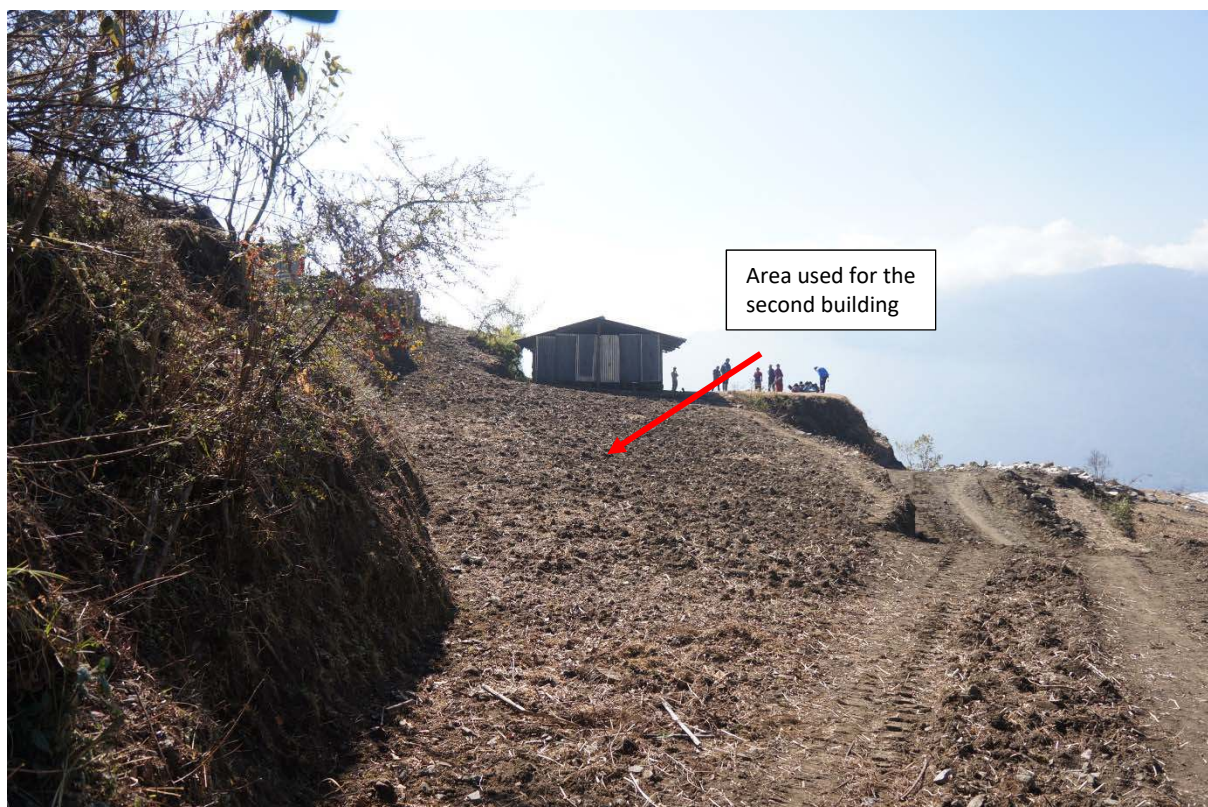
Figure 5-4 The second building will be placed on this farm land. The top soil must be removed and the ground levelled. The slope behind the building should be secured with a gabion wall in order to give safety and better light.

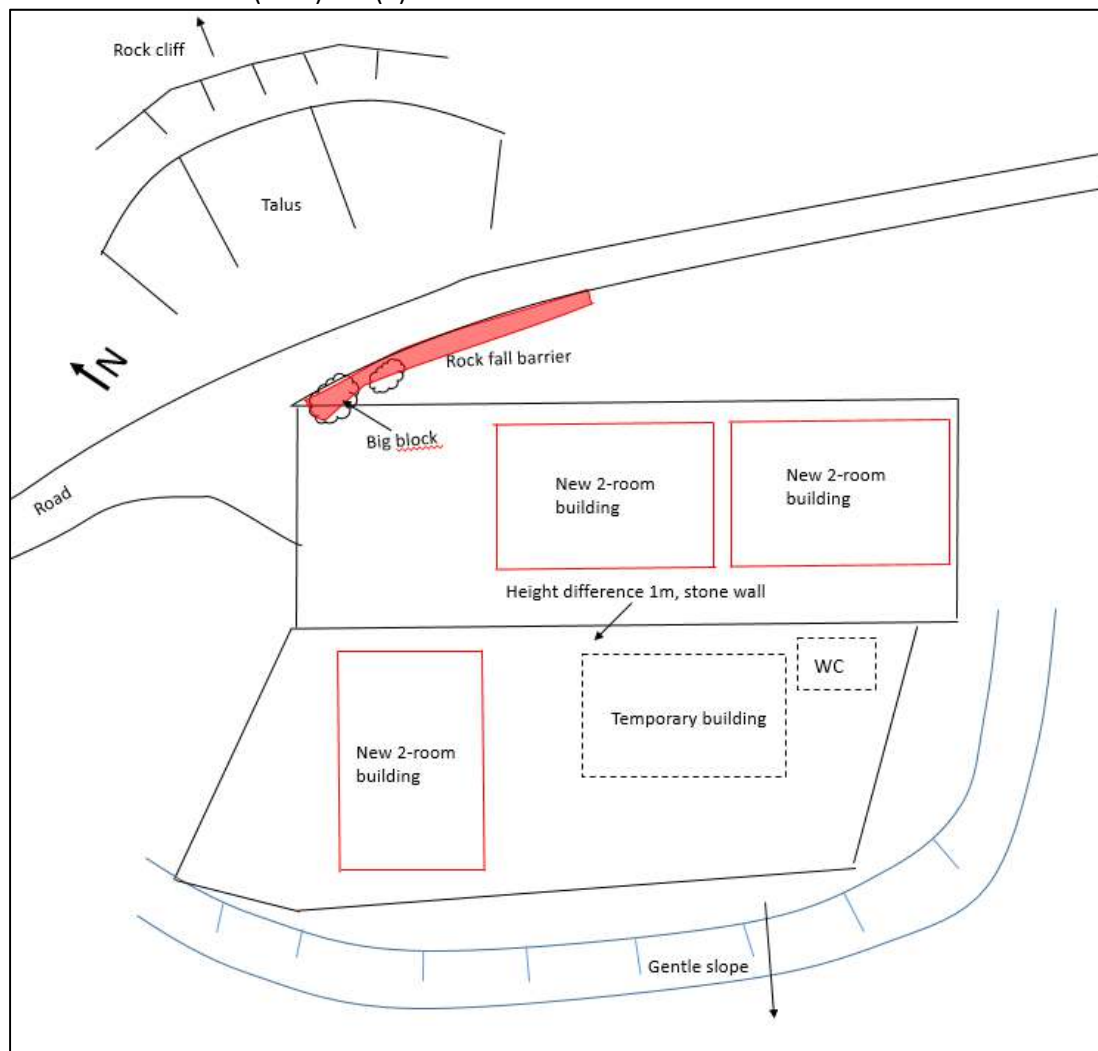
Figure 6-1 Plan view - Setidevi. There is an existing barrier between the road and the school site. This should be supplied with blocks from the upper side of the road in order to function as a rock fall barrier.

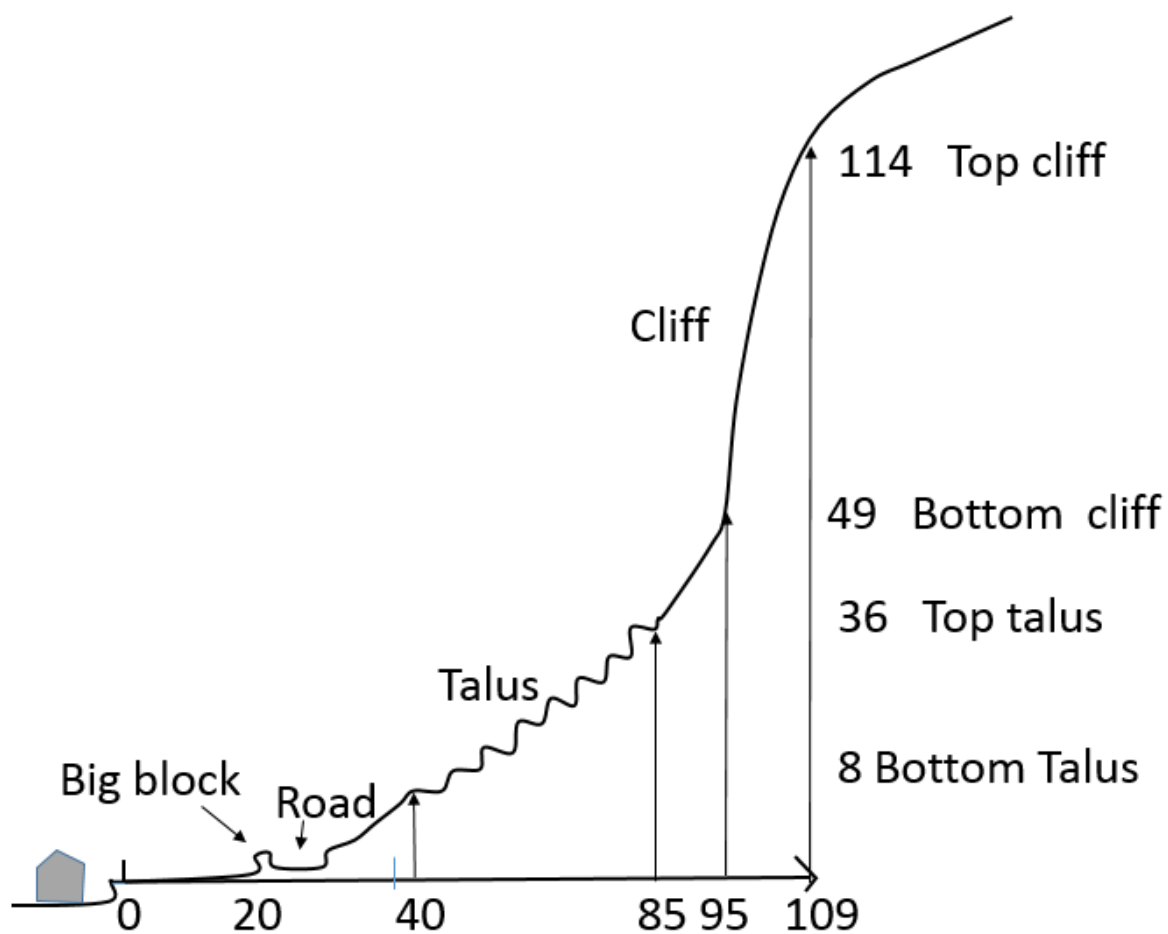
Based on statistical study of rockfall in Norway, a smaller fraction of the blocks has longer runout distance than to the foot of the talus. Using this experience, the zero pint in the profile figure (wall between the two schoolyard levels), correspond approximately to a 400-years runout (annual probability 1/400). 100 years runout is just on the upper side of the road. A rockfall barrier will not stop all blocks, but typical statistical stop more than half of the blocks (some jump higher). We recommend improving the safety against rockfall as it can be done quite simple with local blocks.

Figure 6-2 Profile from schoolyard up to the top of the cliff. The profile corresponds to the section through the big block in the next figure. Unit is meters horizontal and vertical
