12.02.2018

Field work in Dolakha District

Assessment of landslide and slope
stability at 11 schools.

FORUT

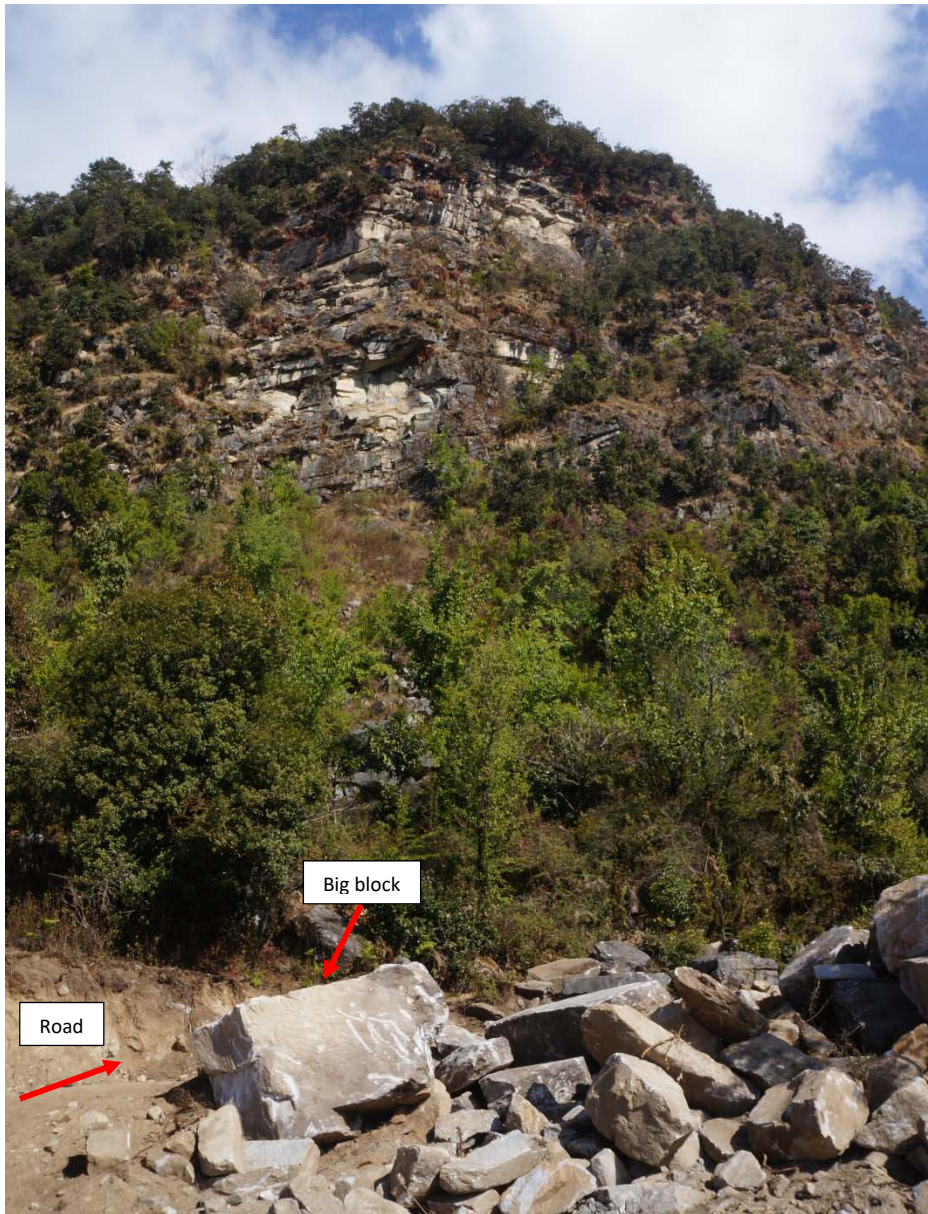
Figure 6-3 The cliff behind Setidevi. The road goes behind the blocks in the front. The talus stops before the road, but scattered blocks from rockfall exist downside the talus. Light areas on the cliff show the more recent outfall areas. "Younger" blocks are found inside the talus. The profile shown in the next figure, cross the big block to the left in the front. An improved rockfall barrier can be made by constructing an embankment/dam from the blocks upside the road.

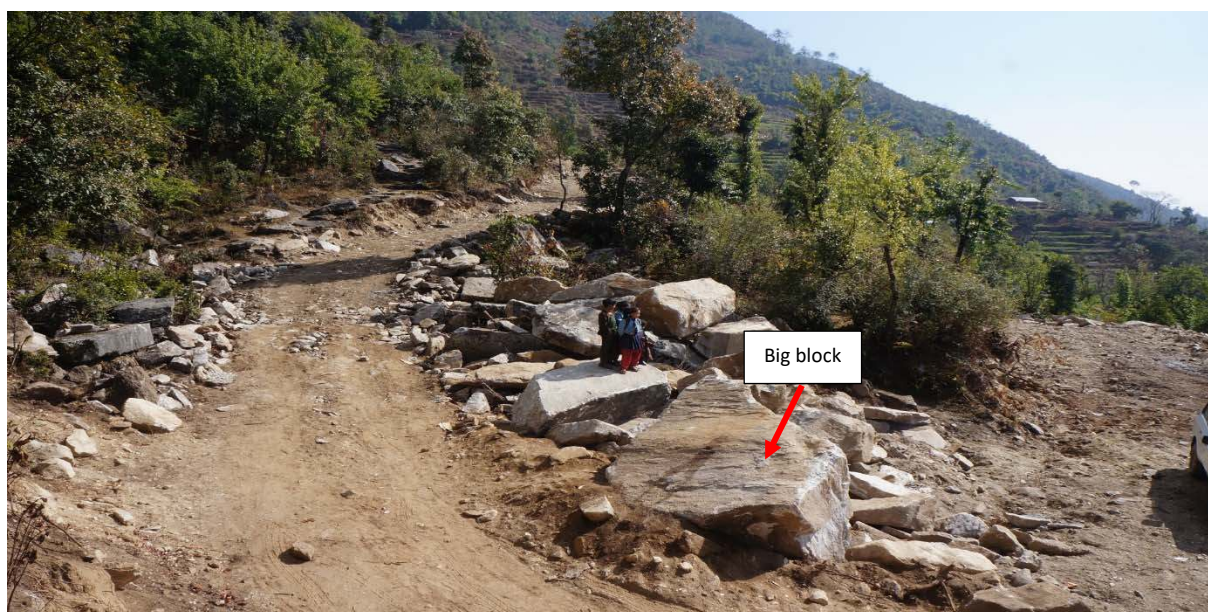
Figure 6-5 Road. The rockfill embankment should be placed from the first big and blockwards, until the road bends to the right.

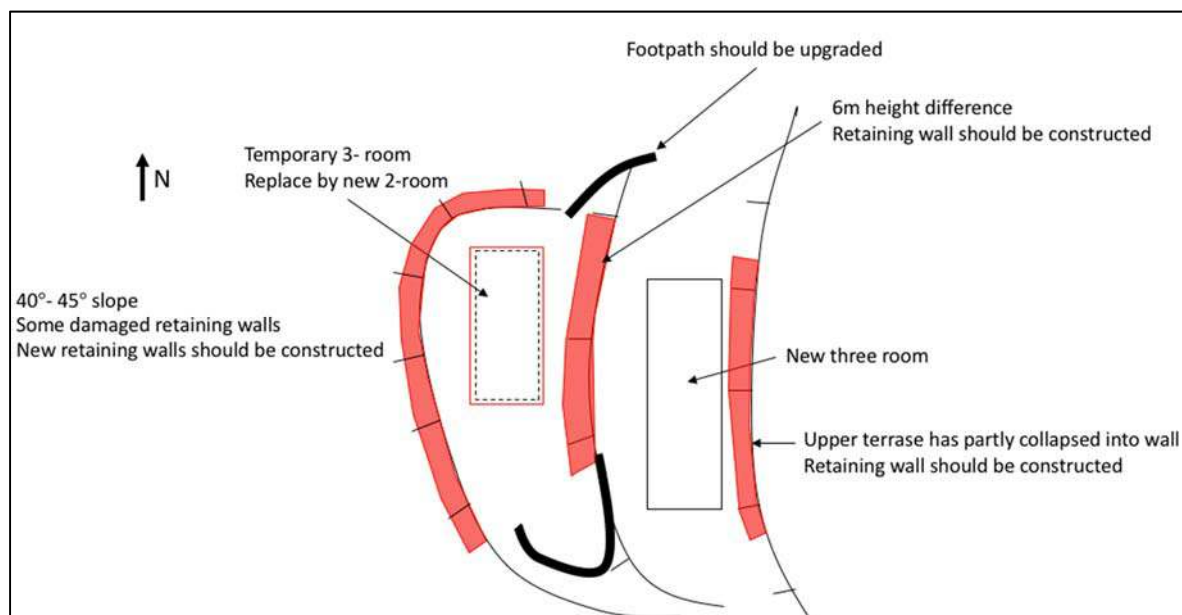
Figure 7-1 Plan view - Chirkun Than. The height difference between newly built- and temporary school building is 6m. There should be carried out extensive work with retaining walls at the site. There is need for a gabion wall both behind the newly built house, between the two houses and in front of the planned building.

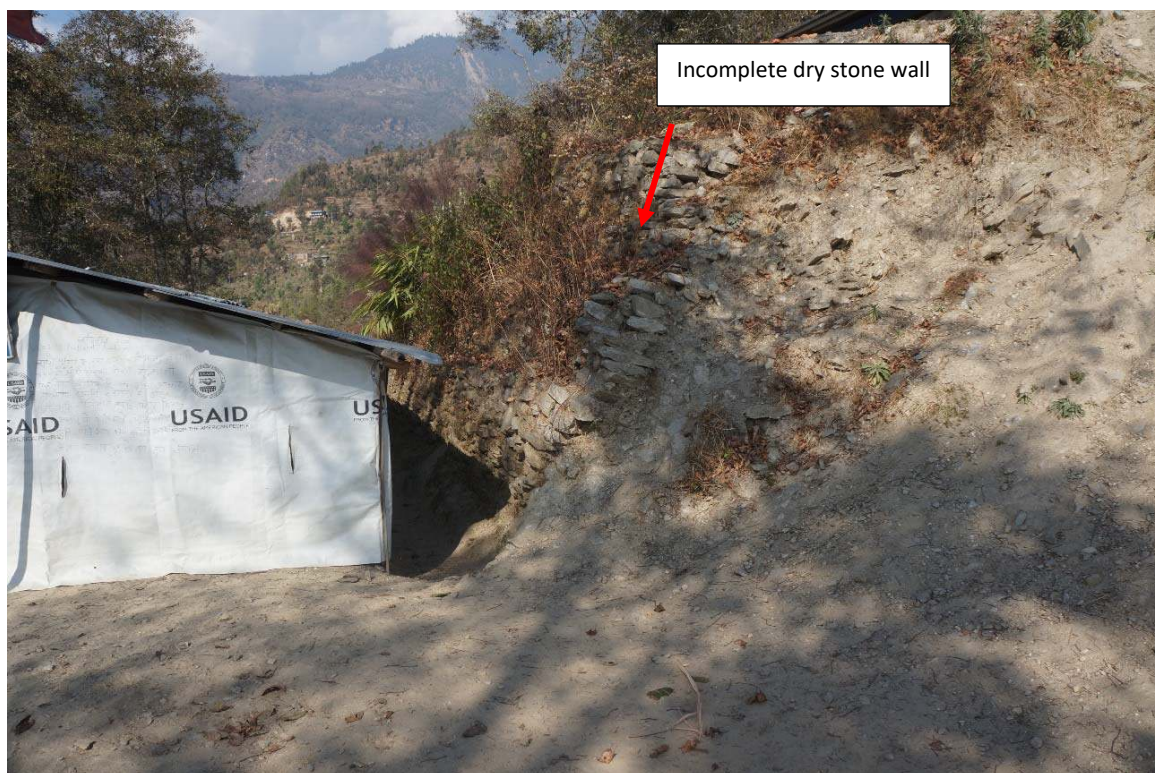
Figure 7-2 Slope, incomplete dry stone wall, between the new and temporary building.

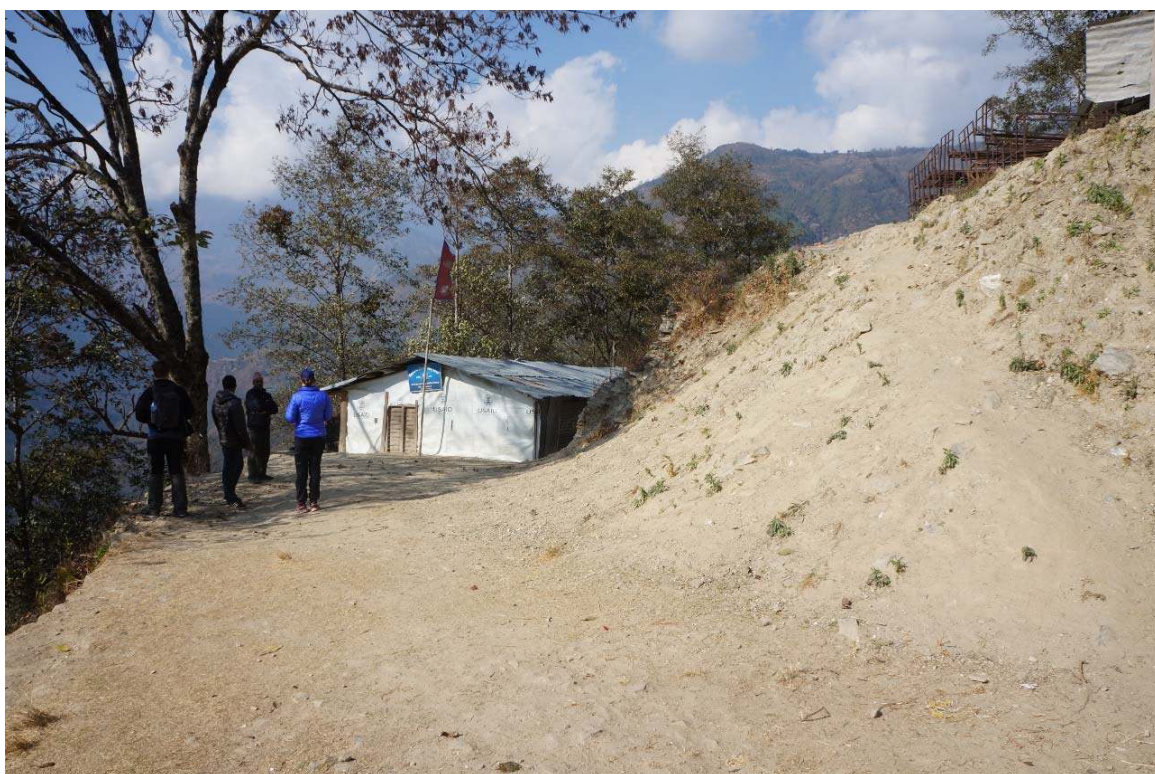
Figure 7-3 Lower plateau. Slope between the upper (new building not completed), and lower plateau must be stabilized.

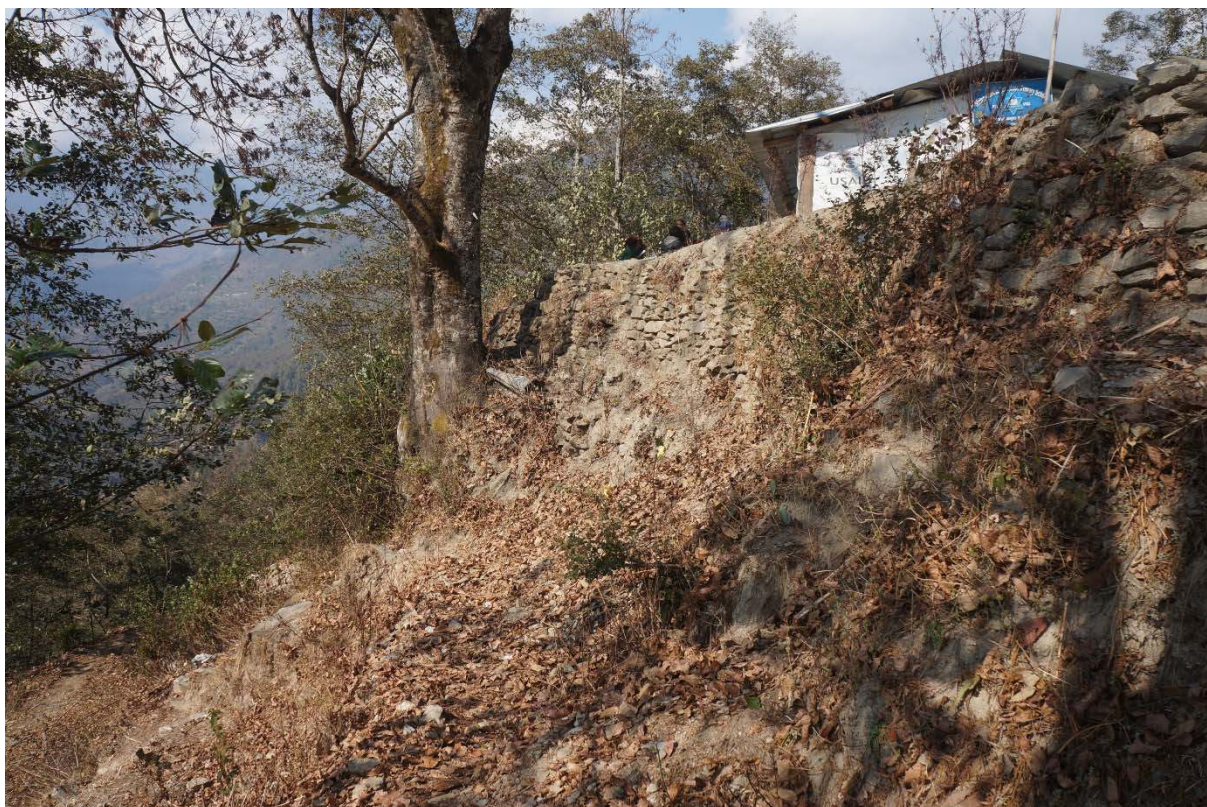
Figure 7-4 The tree stabilize the corner of the wall, movements below the tree and behind the tree, see next picture.

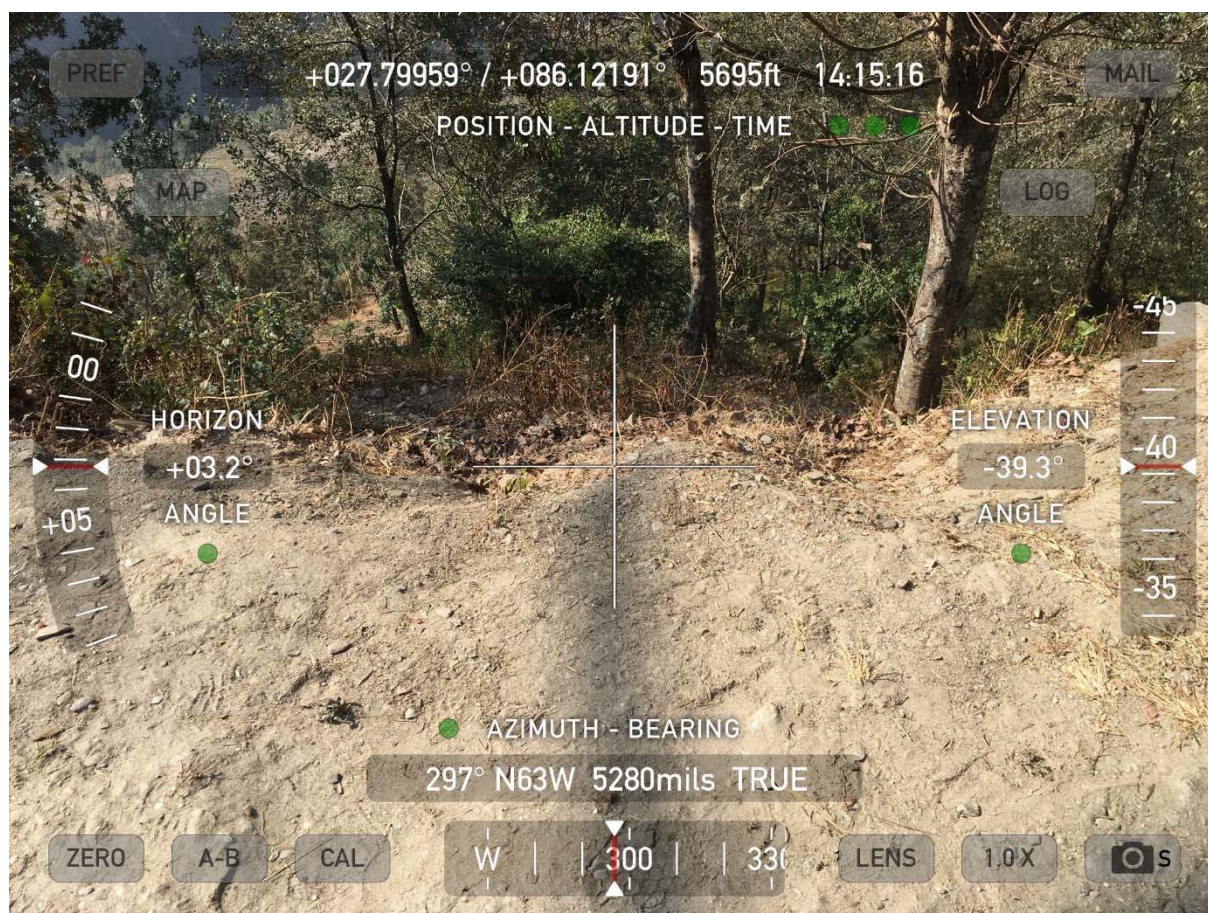
Figure 7-5 Slope failed outside temporary building, north of tree.

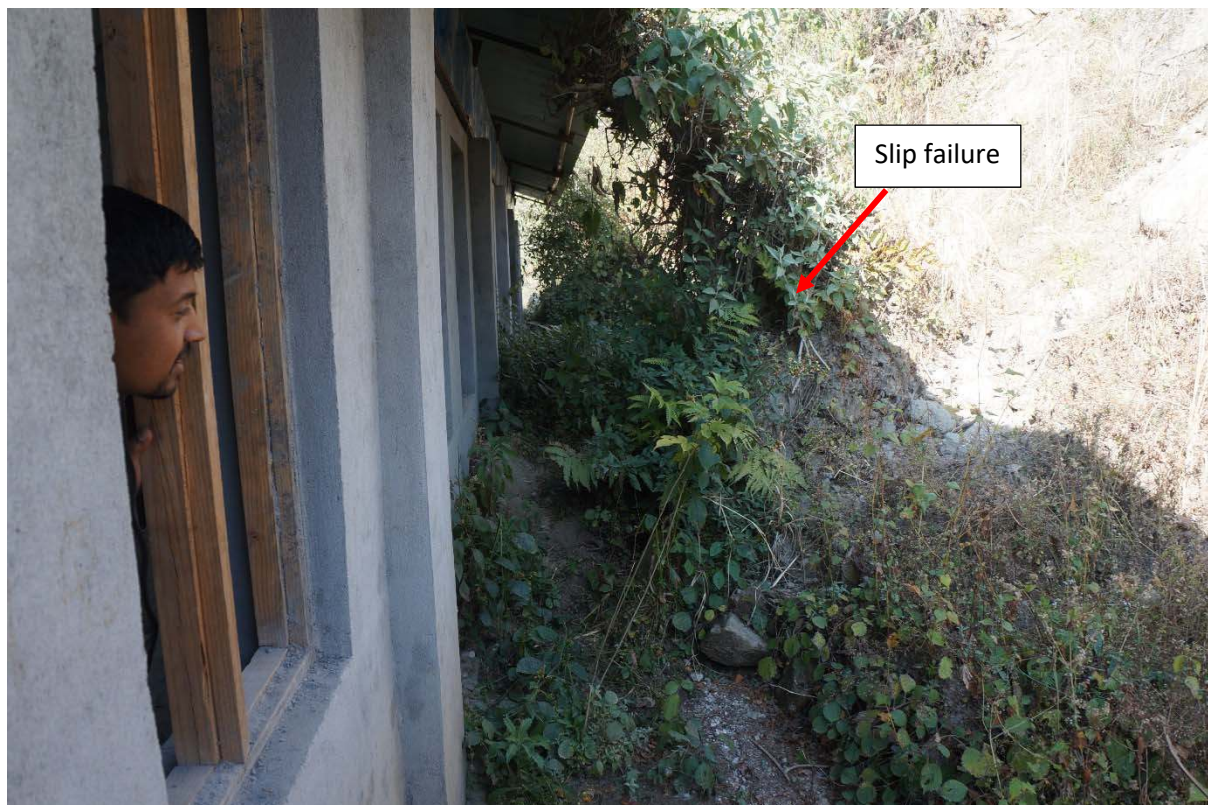
Figure 7-6 Slip failure in the slope cut behind the new school. Gabions wall are required, preferably in steps.

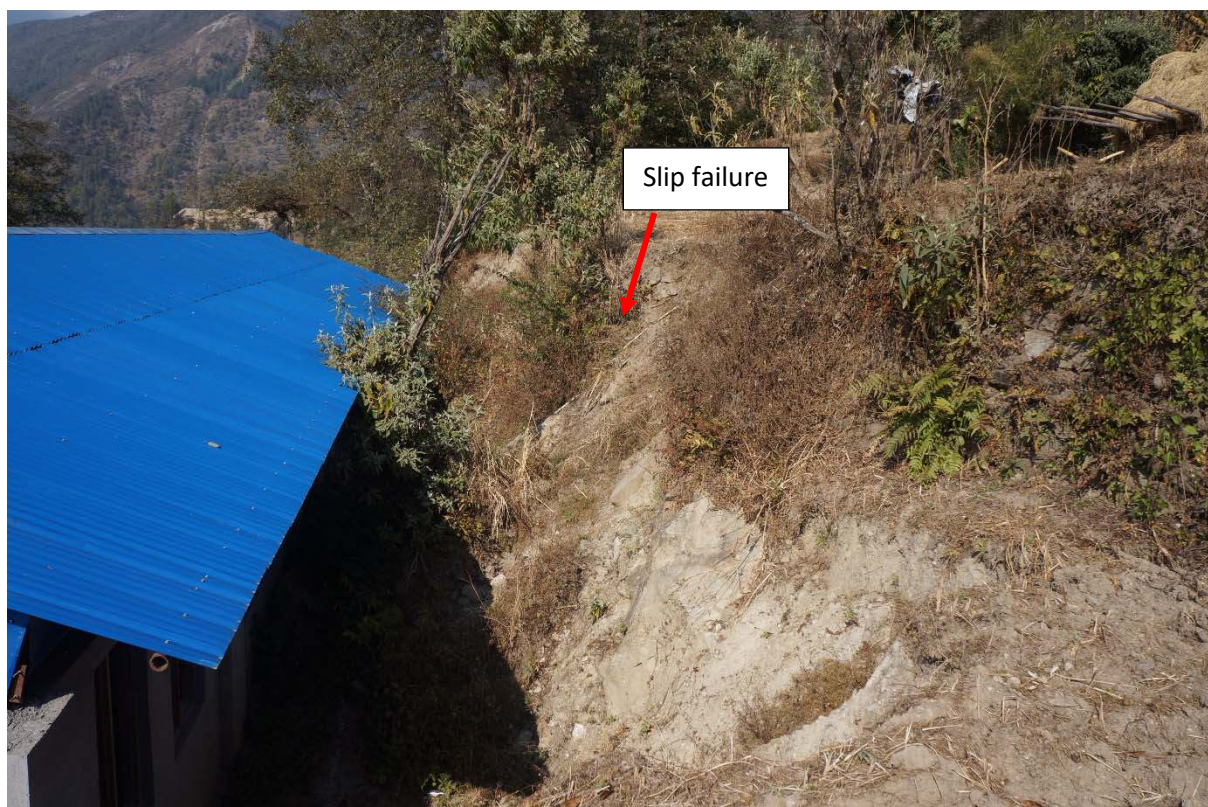
Figure 7-7 Upper part of the slip failure. The slope has been cut into an existing terrace.

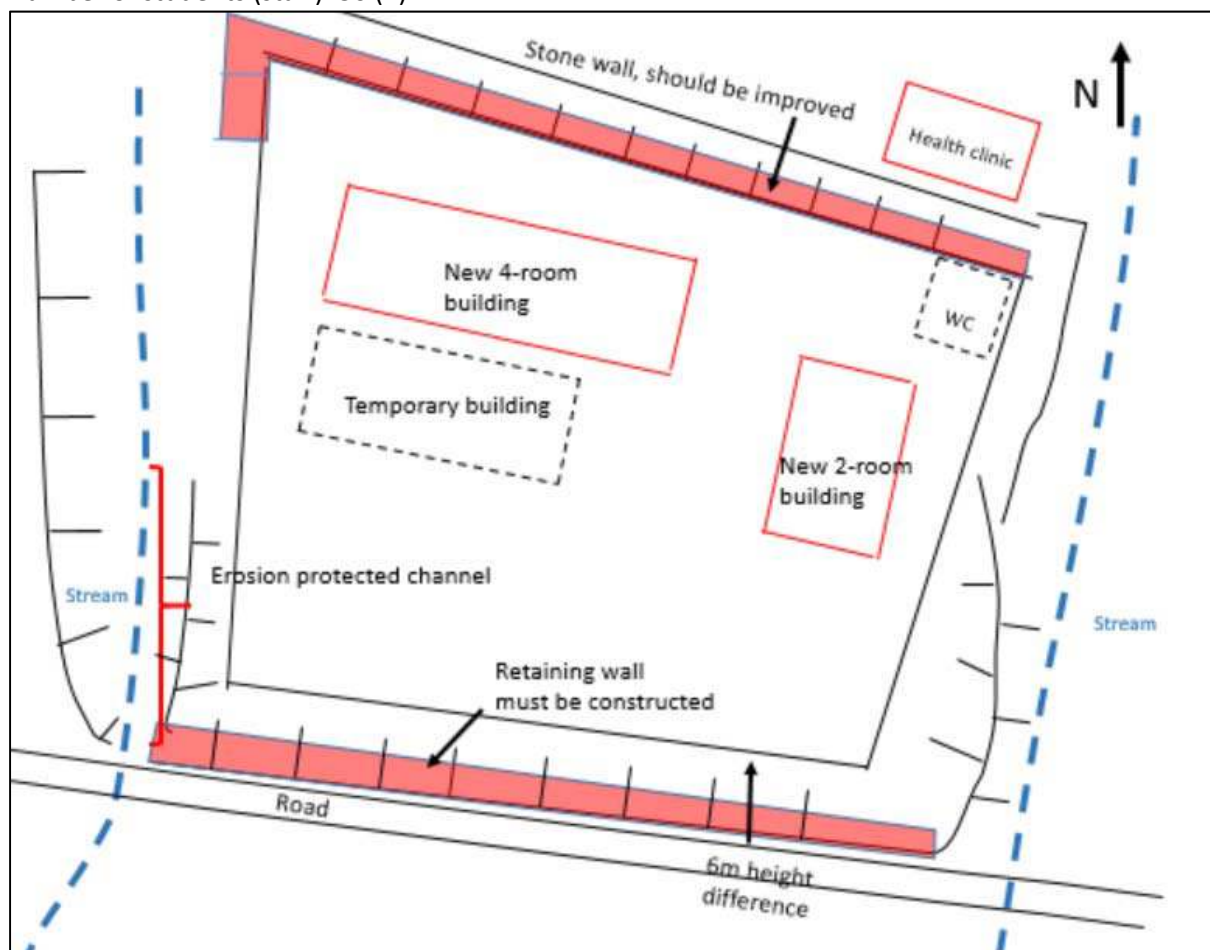
Figure 8-1 Plan view – Deadhunga. A retaining wall south of the plot should be constructed. The western stream should be secured by building an erosion-protected channel to avoid water into the school plot during critical rainfall. The masonry wall north of the site should be improved slightly.

There is a masonry wall north of the plot. The wall is generally in good condition, but some of the upper stones are loose, and should be fixed. There should also be a retaining wall upside the slope against the access road. The height of the slope is here about 6m.

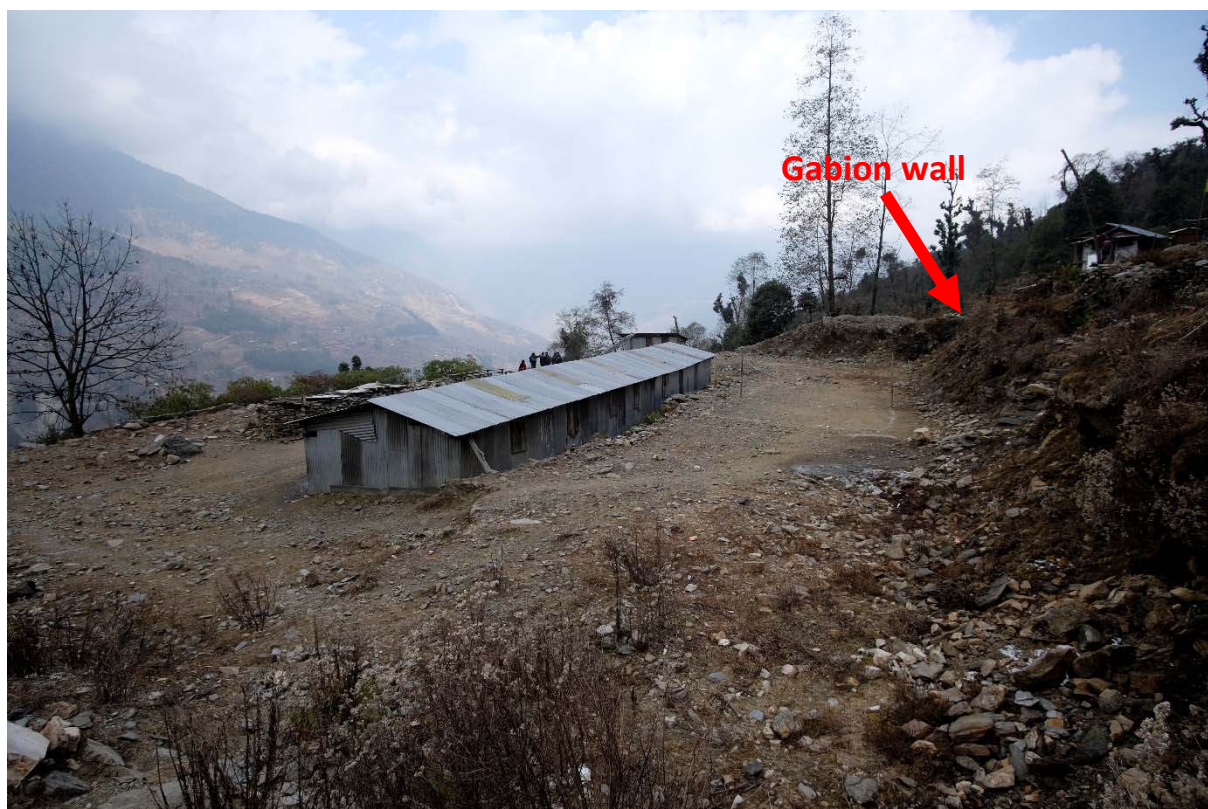
Figure 8-2 The southern slope should be secured with a gabion wall. The boundary of the plot should be well defined so that no masses are deposited in the slope.

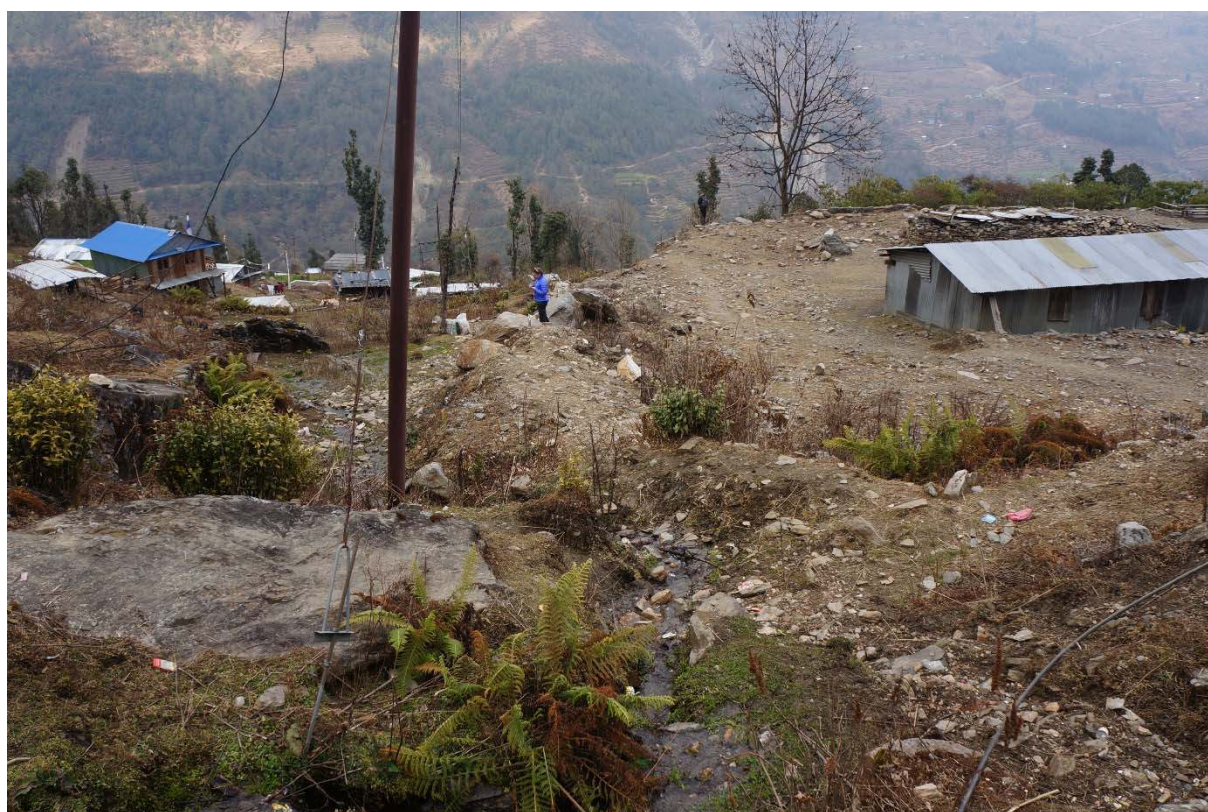
Figure 8-3 The stream at the western side need to be led in a channel and erosion protected rip-rap at the top of the plot. The stream at eastern side is controlled by the depression (a low pass) in the road.

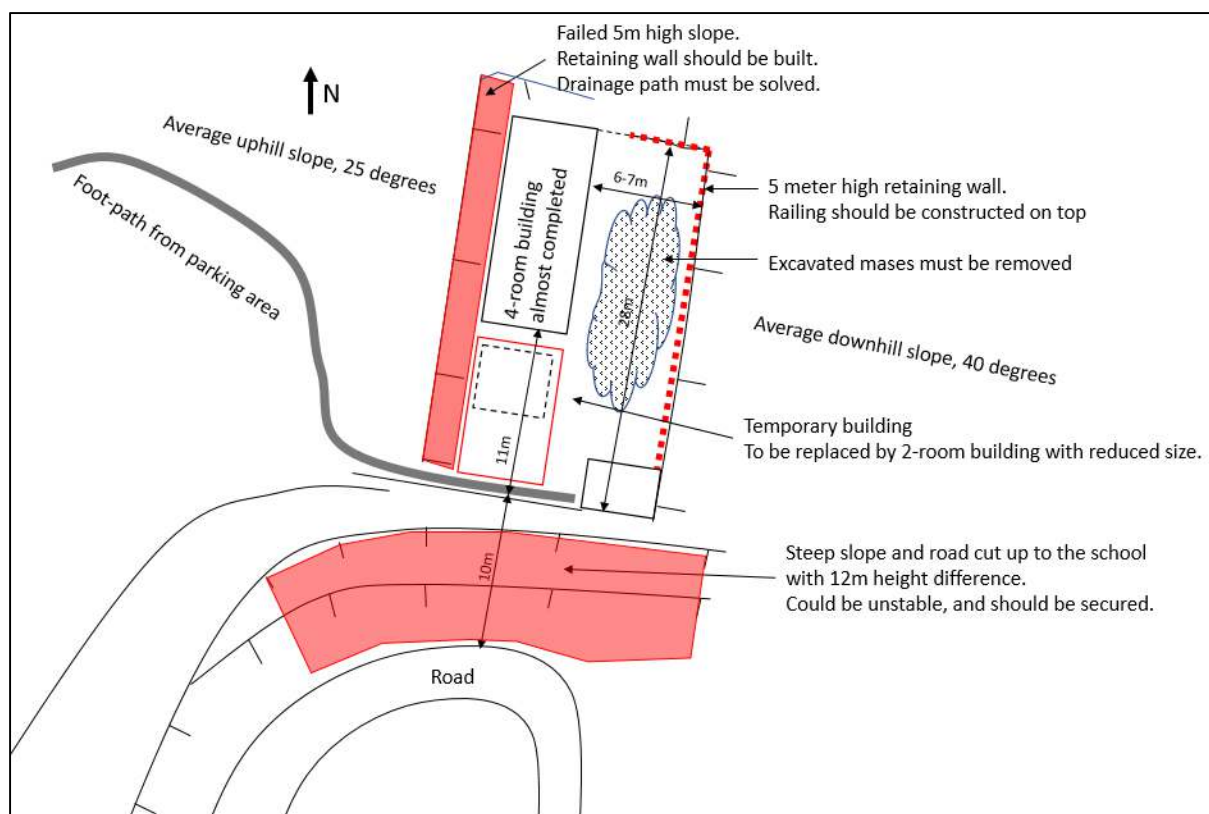
Figure 9-2 Plan view – Jana school. A gabion wall should be constructed, both at the backslope failure already has occurred (west) and at the slope towards the road (south) where the height difference is 14m. Water from the terraces should not be permitted to flow down the backslope. For safety, we recommend to railings in front of the school where the wall height is about 5m and the slope continues steep downwards.

There is a gabion (4-5 levels) wall in front of the area (east). Generally, the wall is in good condition. The backwall of the school building (west) is 5m high, and this wall is not sufficiently supported (only a one level gabion wall behind half of the building).

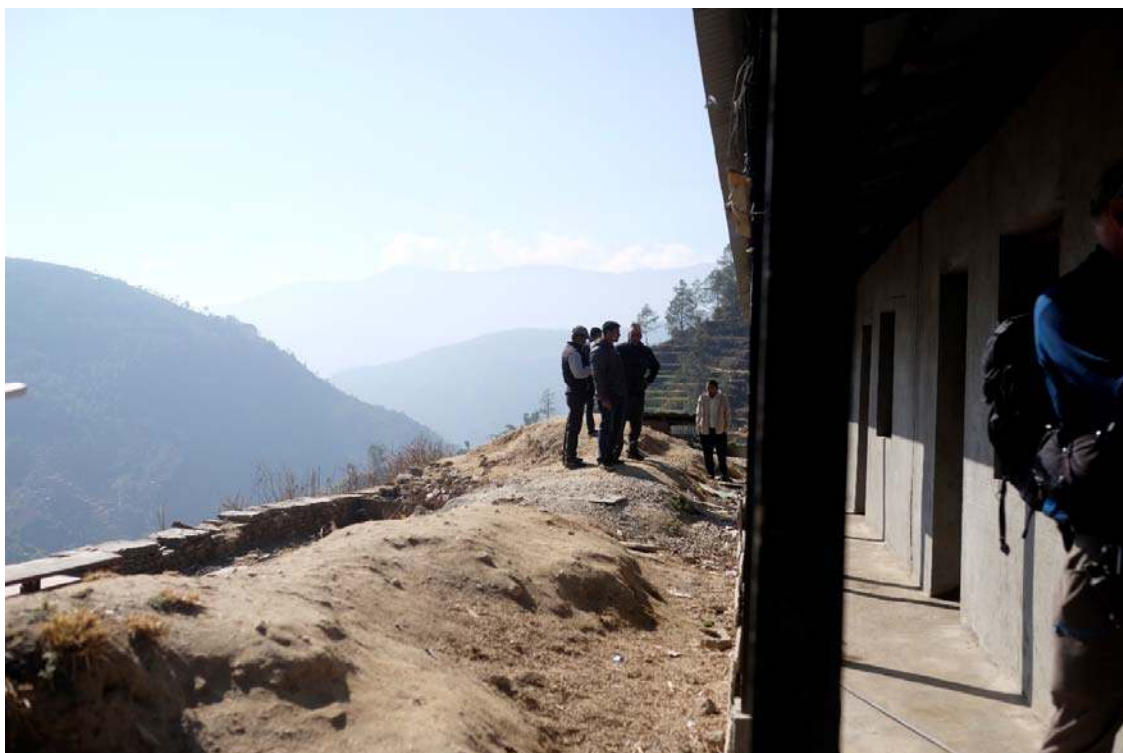
Figure 9-3 Excavated masses adds load on the retaining wall behind. These masses should be removed before further construction starts.

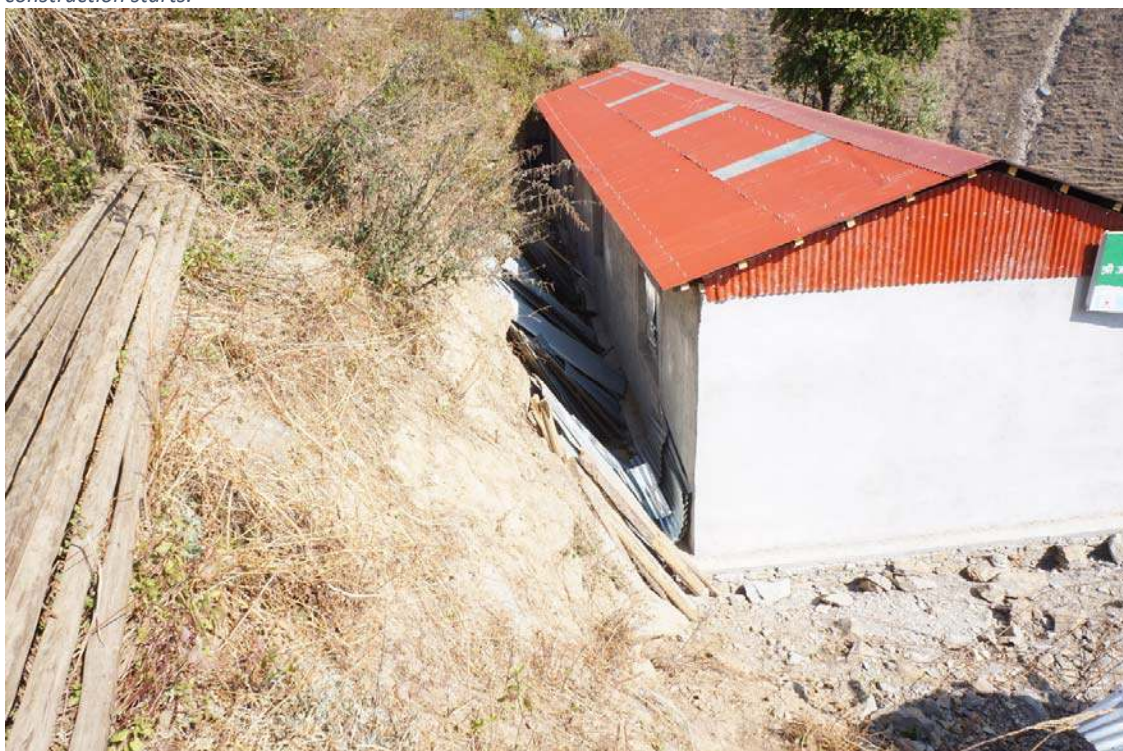
Figure 9-4 The slope behind the building is about 5 m high. Along the northern part there is a gabion in one level at the bottom, and two levels in the northern corner. The slope has failed in northern part and should be secured by a retaining wall.

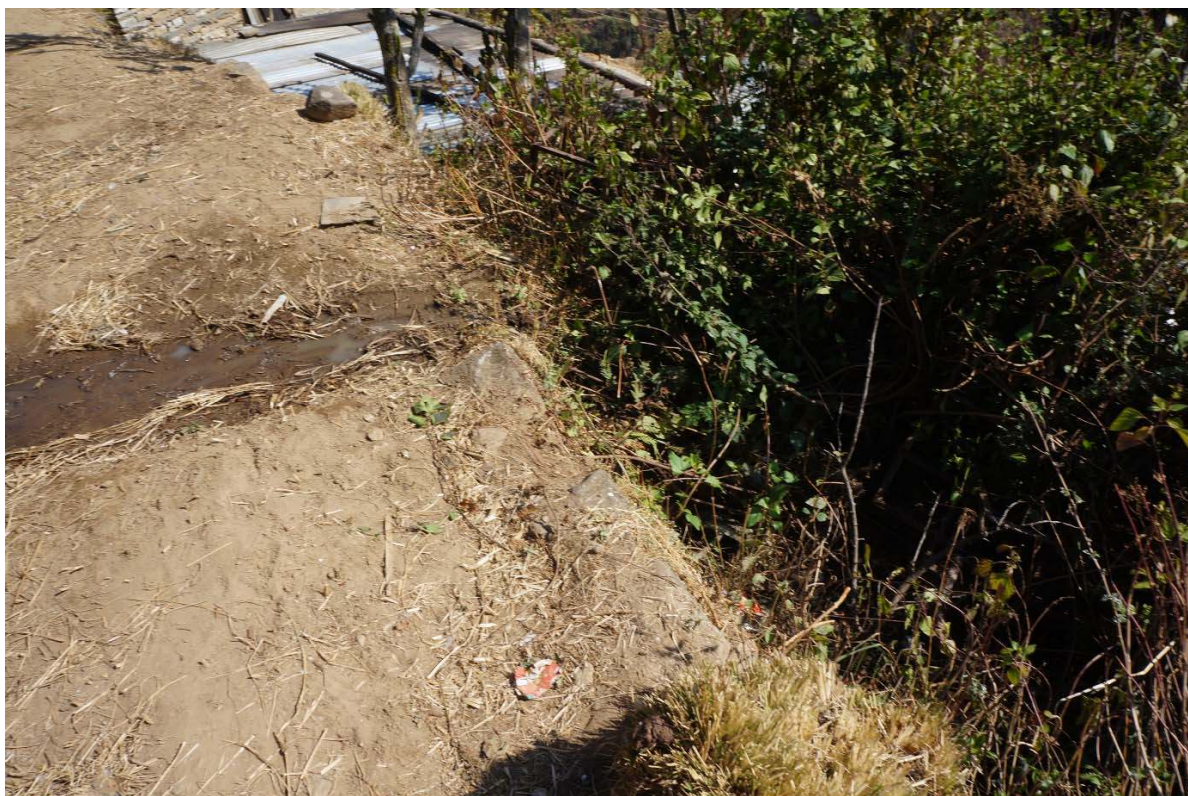
Figure 9-5 Water is flowing from the neighbour's kitchen, close to the northern end of the excavated slope. Water should not flow from the terraces down the slope behind the building.

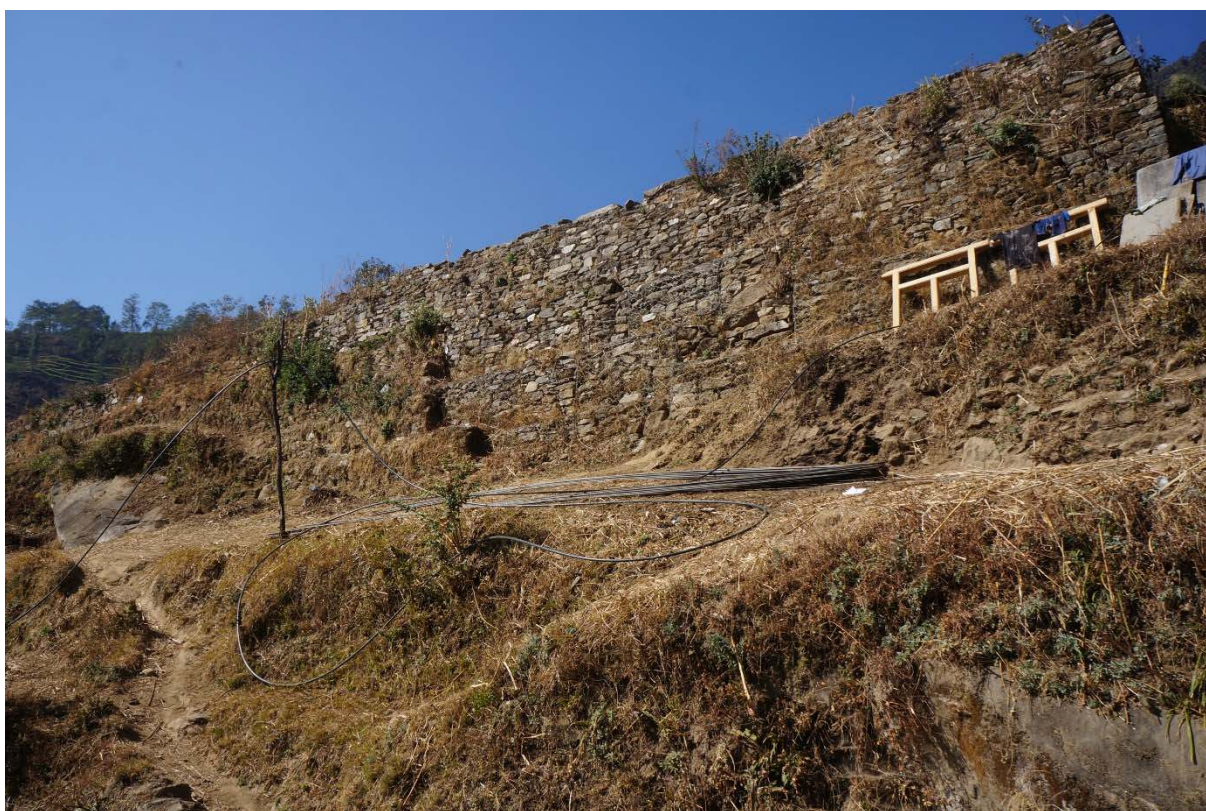
Figure 9-6 Retaining wall is 5-6 m high downside Jana. The wall consist of gabions, partly stonewall and interlocked big stones. The top of the wall is levelled about 0.5m above the school yard. The slope angle is $\sim 40^\circ$ in 15 meters vertical distance.

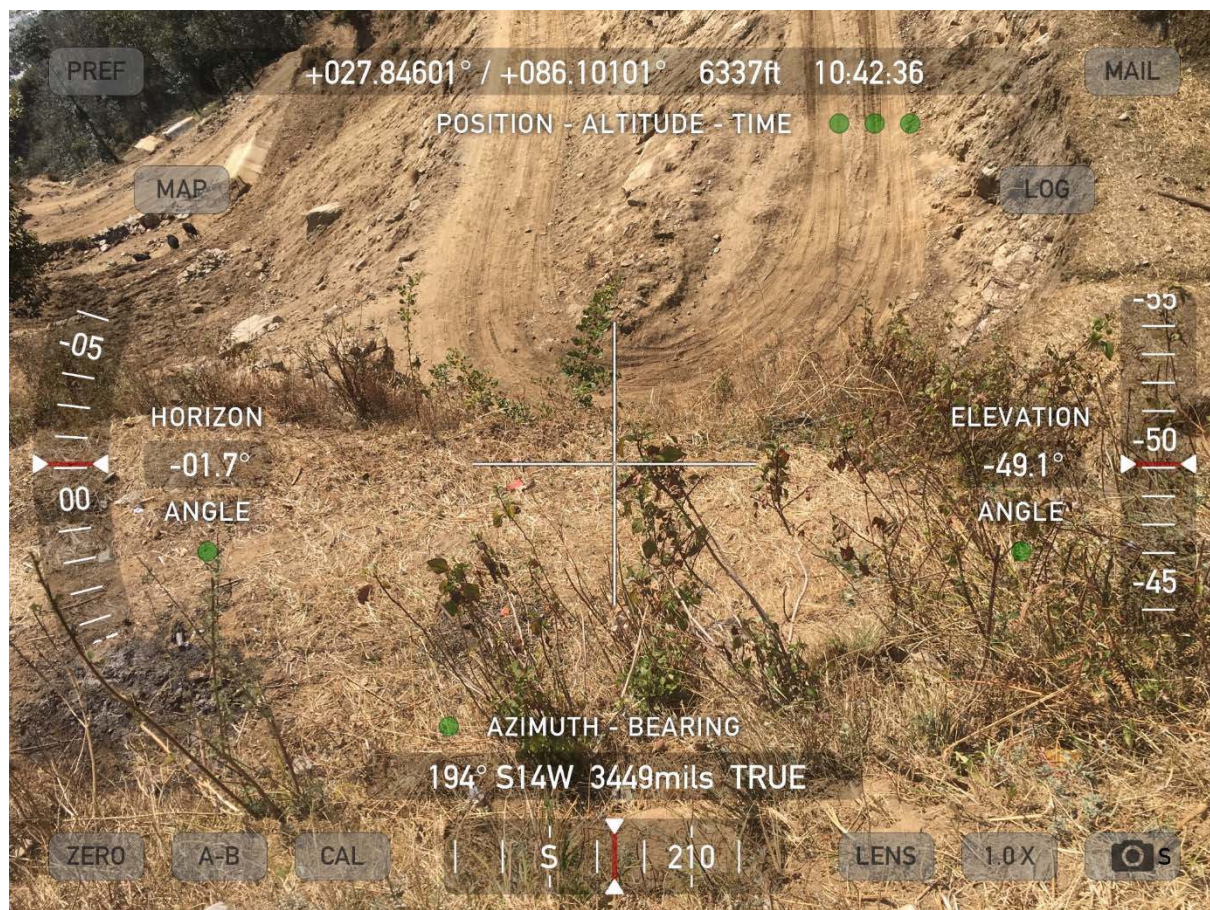
Figure 9-7 The road is maximum 16m lower than the stone stairs that marks the border of the school plot. The road cut needs a gabion wall with at least the height of the road cut. The geometry restrict the use of the southern area of the plot. We do not recommend a 2-room building, rather a 1-room building. There is about 12m between the new building and the stone stairs.

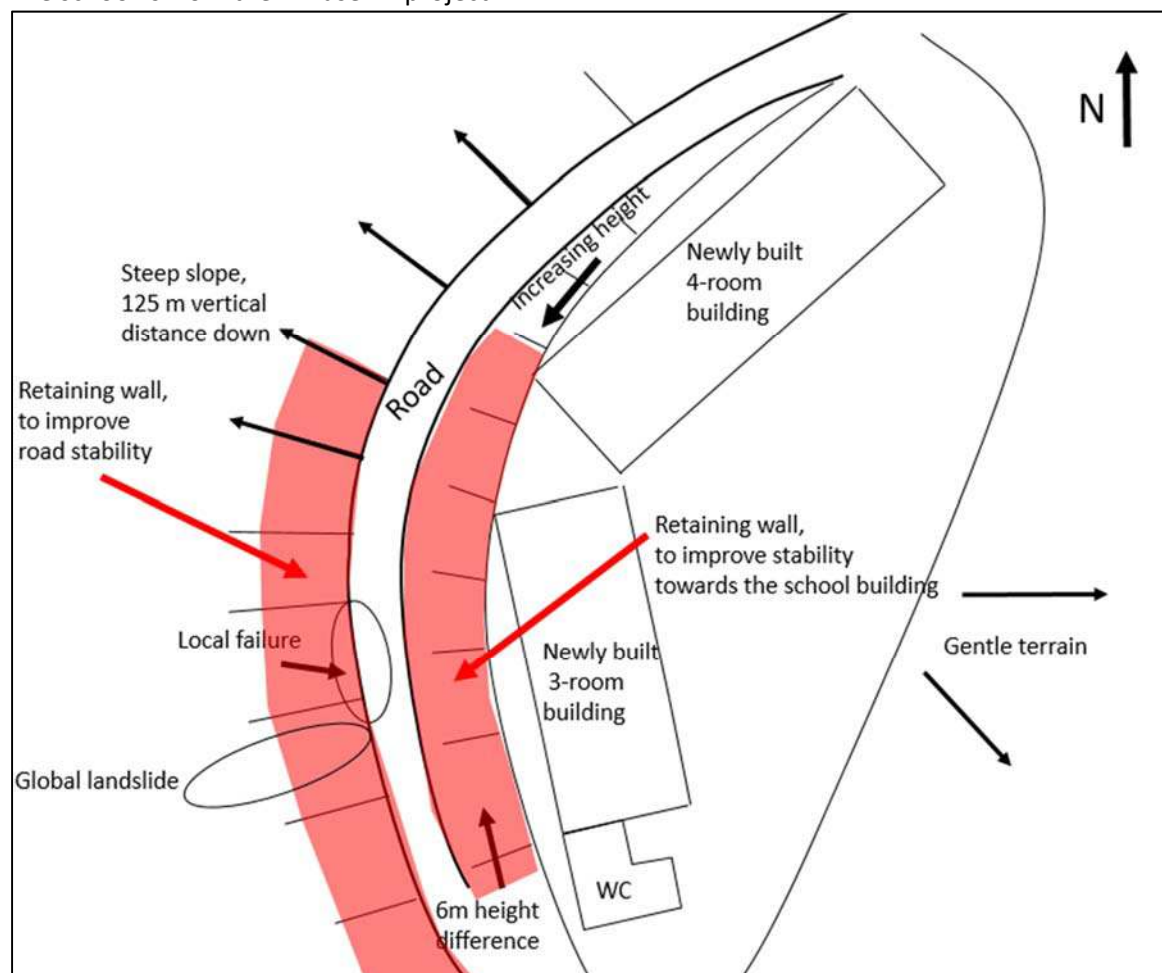
Figure 10-1 Plan view - Himali Devi. Two retaining wall west of the plot should be constructed; one to improve the road stability and one to improve the stability towards the school building.

There has been a landslide (also NW) caused by the construction of the road and a local slip failure of more recent date into the road. This side of the school plot is therefore of most concern. The stability of the road is related to the stability of the southern building. The terrain in the southern and eastern part is gentler.

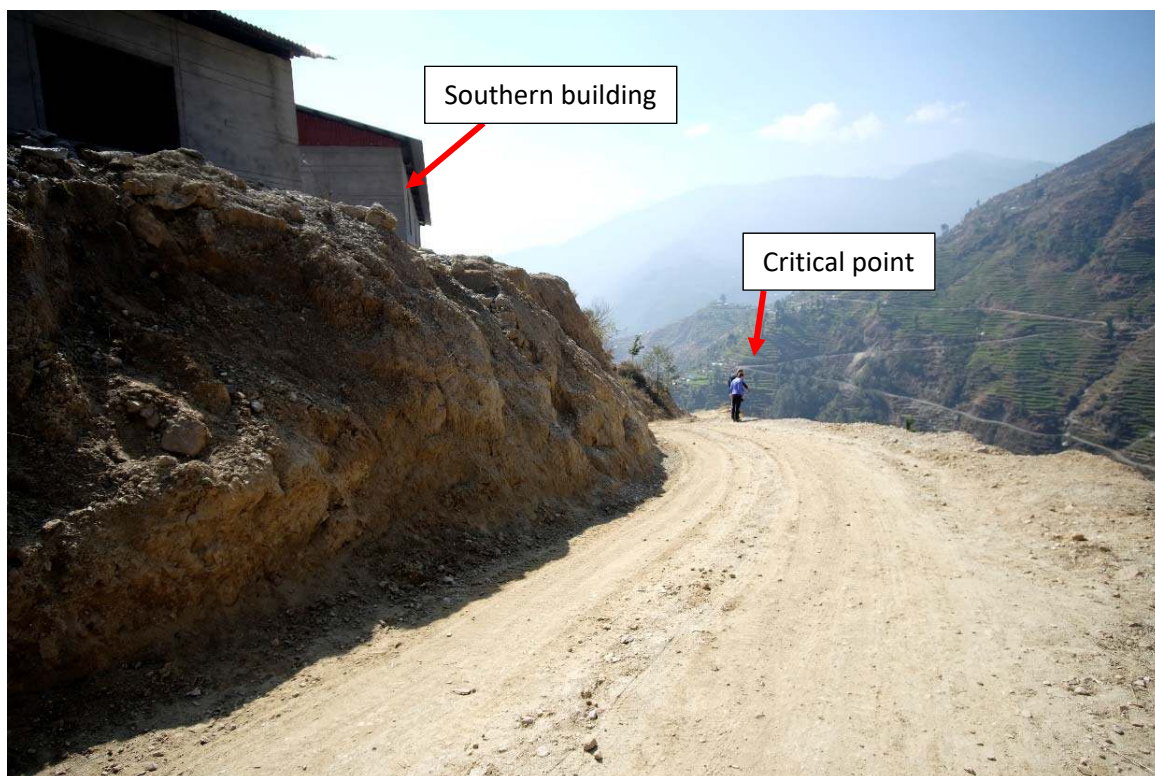
Figure 10-5 Road, west of the school plot. The critical point is where the man is standing. The southern building needs a gabion wall, after the road is secured.

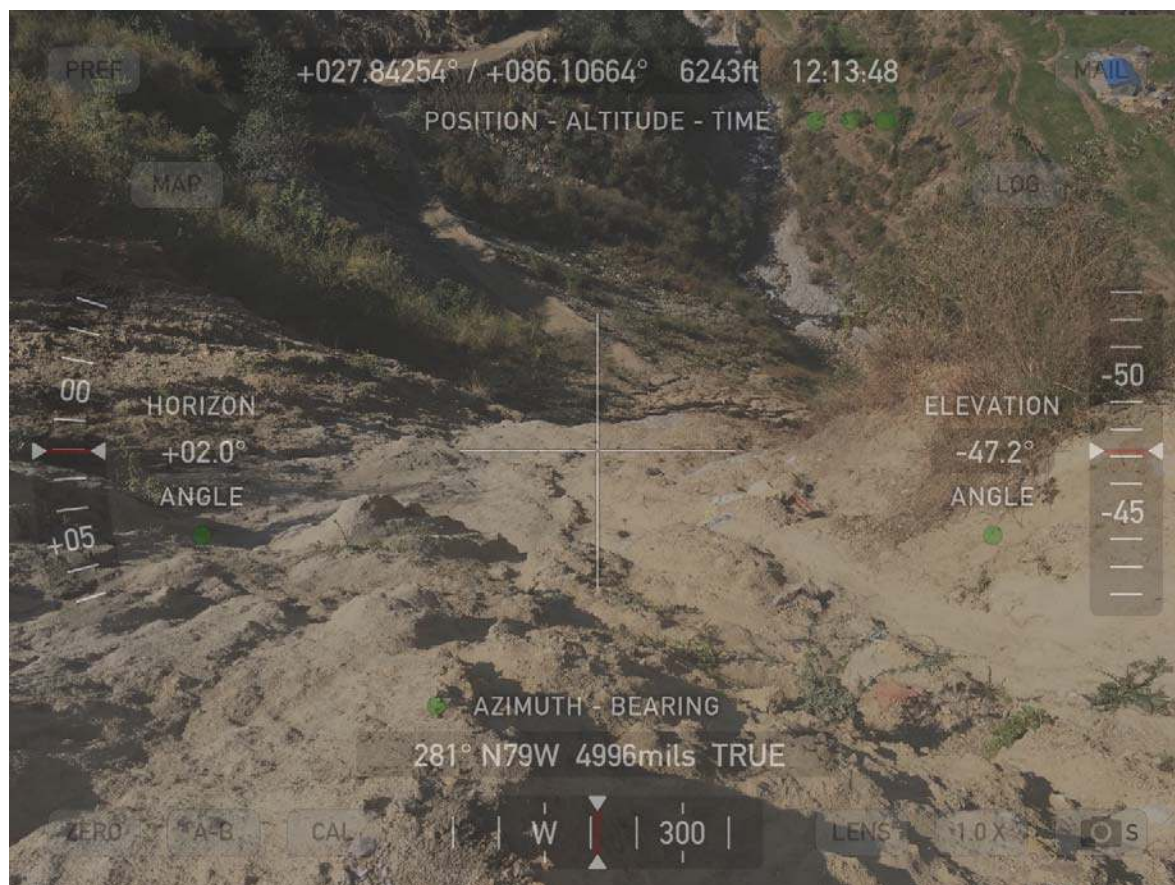
Figure 10-7 The average slope is about 47°. Bedrock is visible about five meters below the road and further north. In the southern direction, the new slide (shown in next figure) most likely covers bedrock.

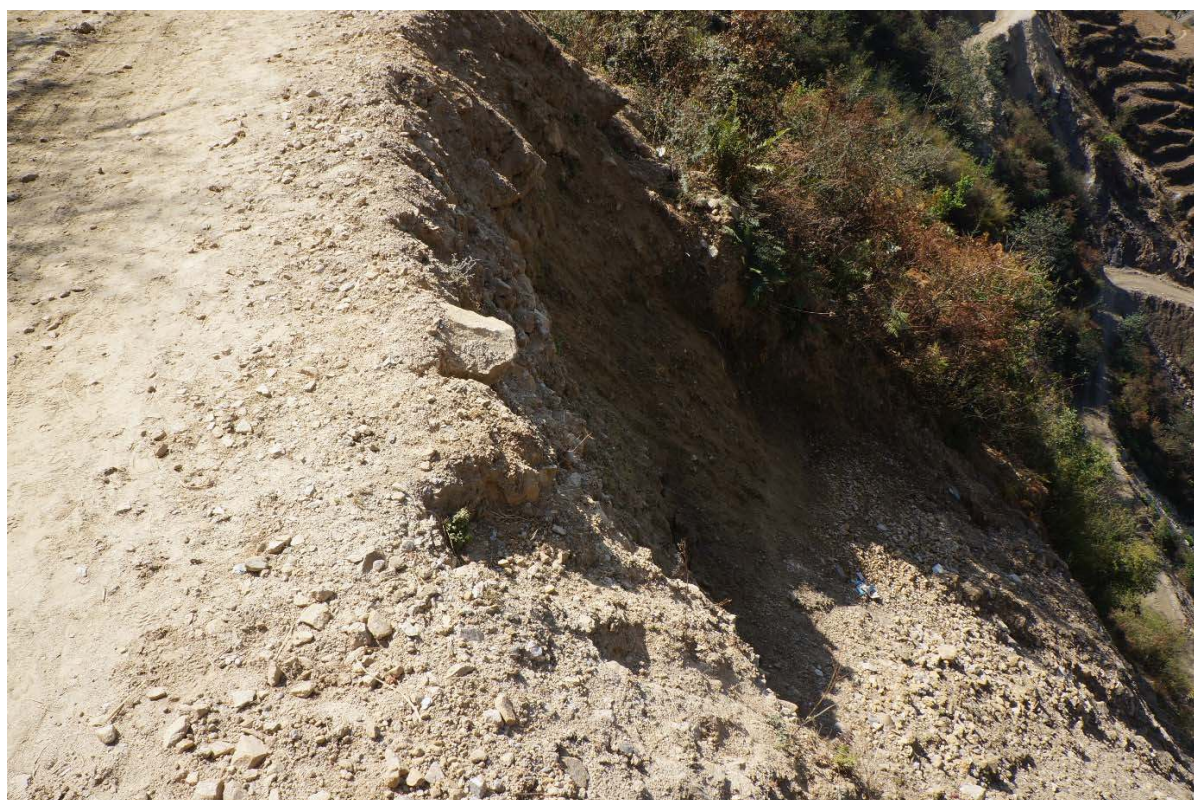
There is a landslides west of the school plot. The instability is caused by the road construction, induced by rainfall.

Figure 10-8 Slide at the edge of the road. Around 10-15 m below, the inclination decrease for some meters, maybe due to bedrock.
