12.02.2018

Field work in Dolakha District

Assessment of landslide and slope
stability at 11 schools.

FORUT

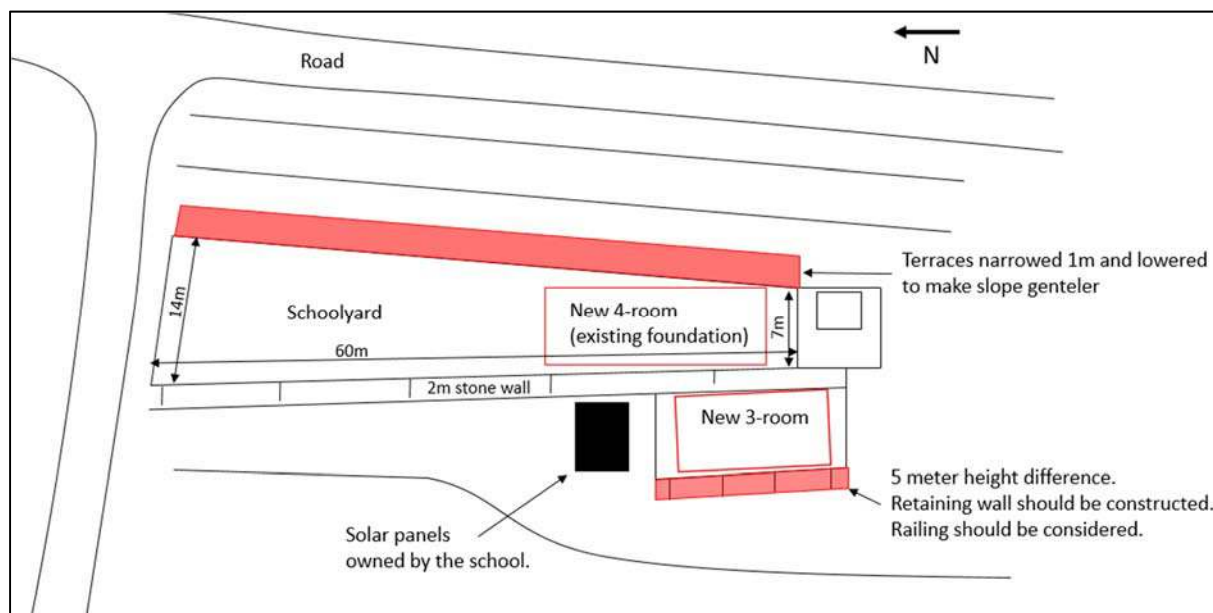
Figure 11-1 Plan view – Himkhande Bhuwaneswori. The slope west (below) of the plot should be secured by a retaining wall..

The slope west (downside) of the area should be secured by a retaining wall. The foundation of the lowermost building will be close to the steep part.

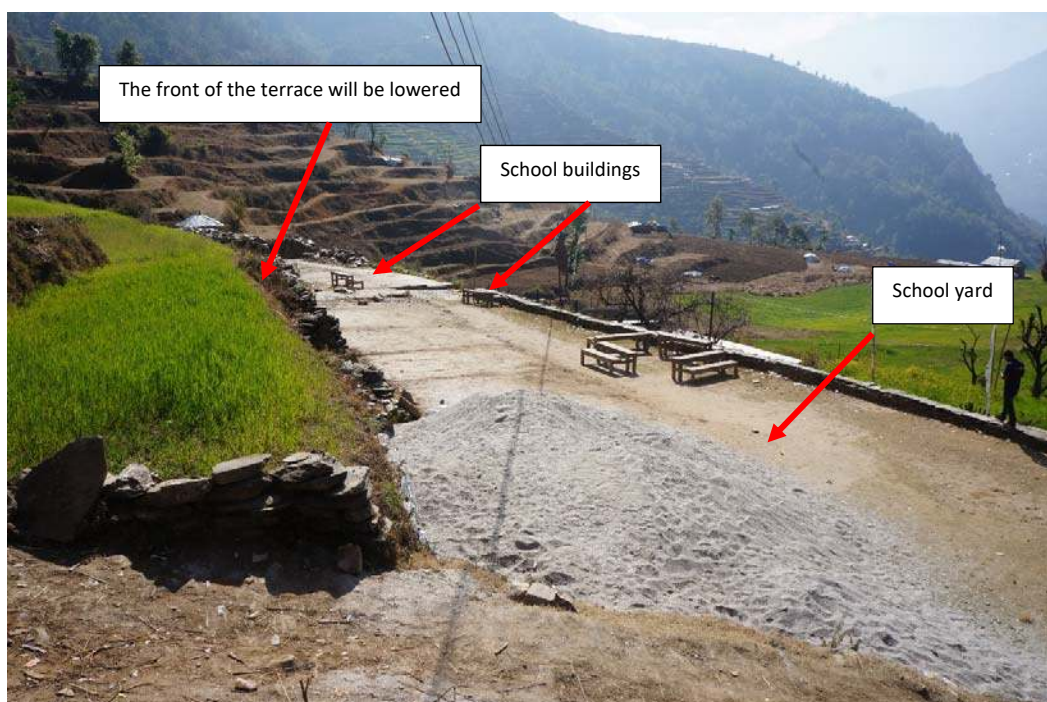
Figure 11-2 Looking south-west. The northern area will be the schoolyard and the two buildings will be placed on the southern area. The terrace above the plot will be narrowed 1 m and lowered.

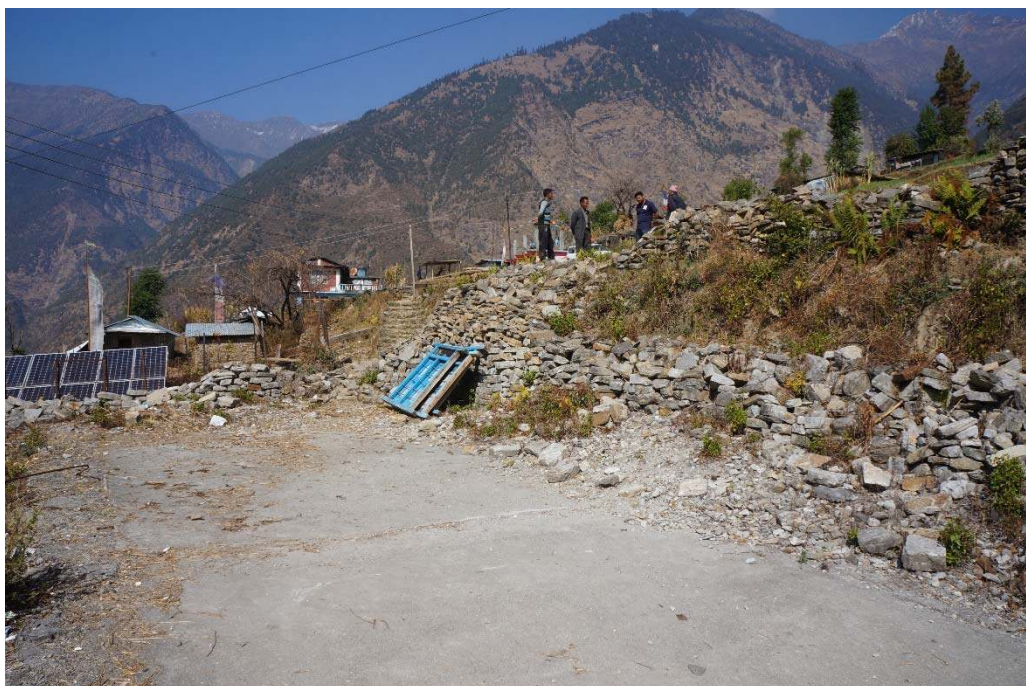
Figure 11-3 The lower part of the plot are fairly narrow compared to the width of the new 3-room building. The slope below (see next figure) must be secured by a reinforced structure.

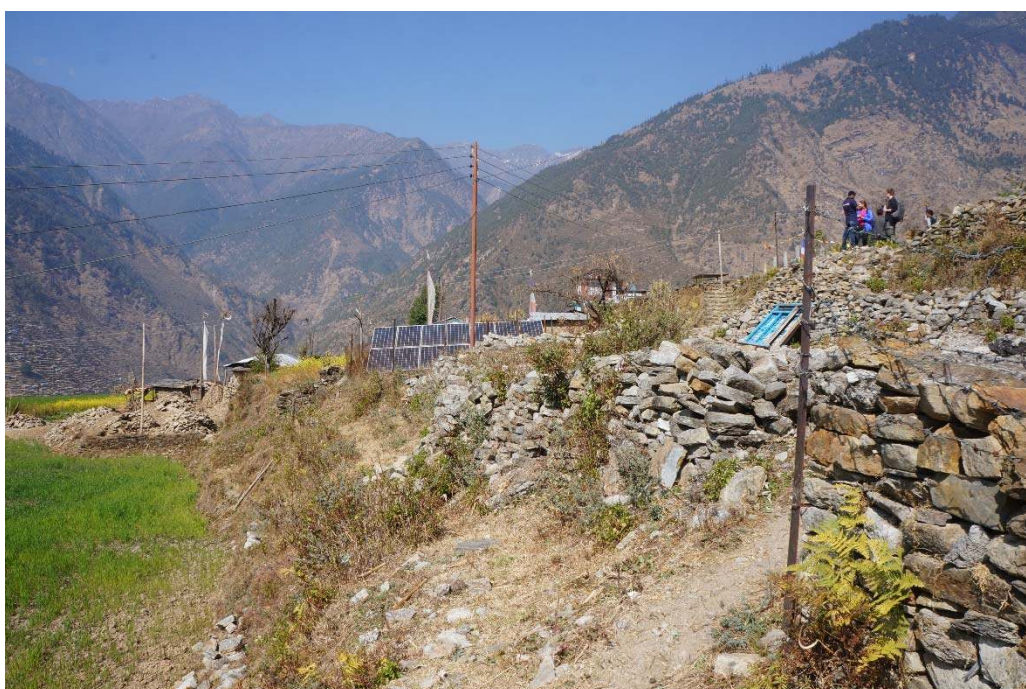
Figure 11-4 The stones are temporary placed at the edge of the plot. The foundation of a new building will need a supporting structure in the slope.

Is it possible to use the remaining foundation for the construction of the new building? (Place the plint on top the existing.)
