12.02.2018

Field work in Dolakha District

Assessment of landslide and slope
stability at 11 schools.

FORUT

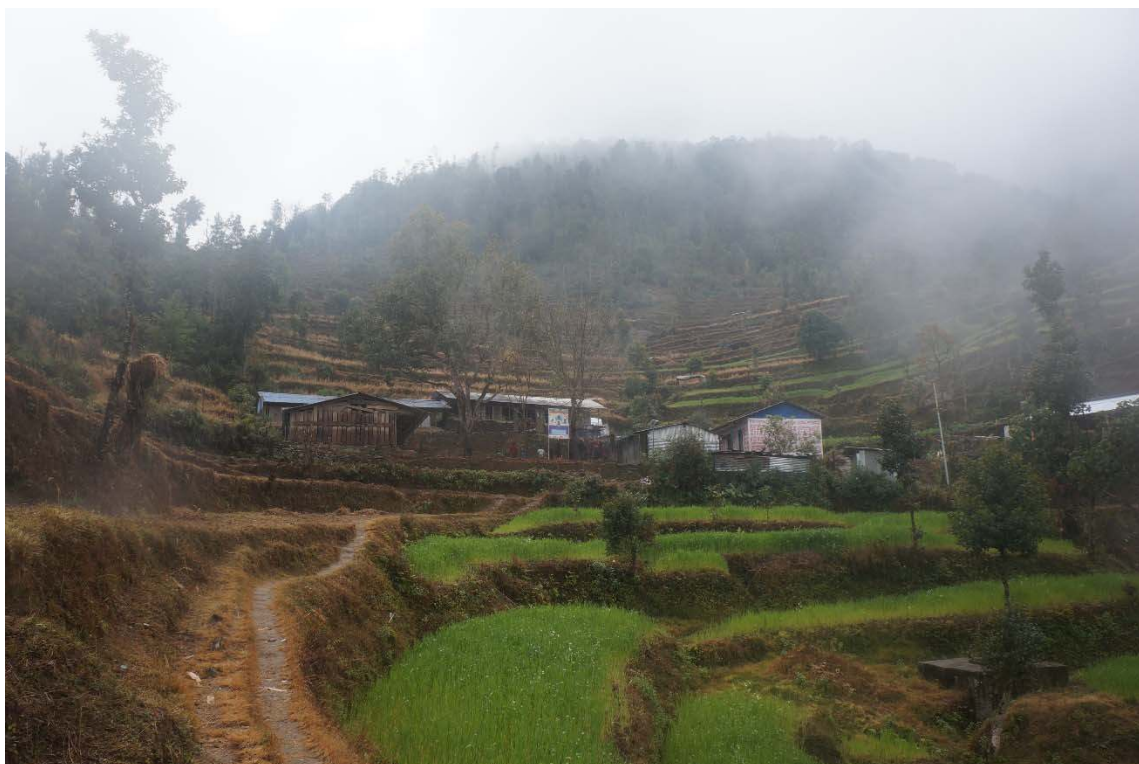
Figure 1-2 Path to Mahadeswori school. The road is approximately 100 m below the school plot.

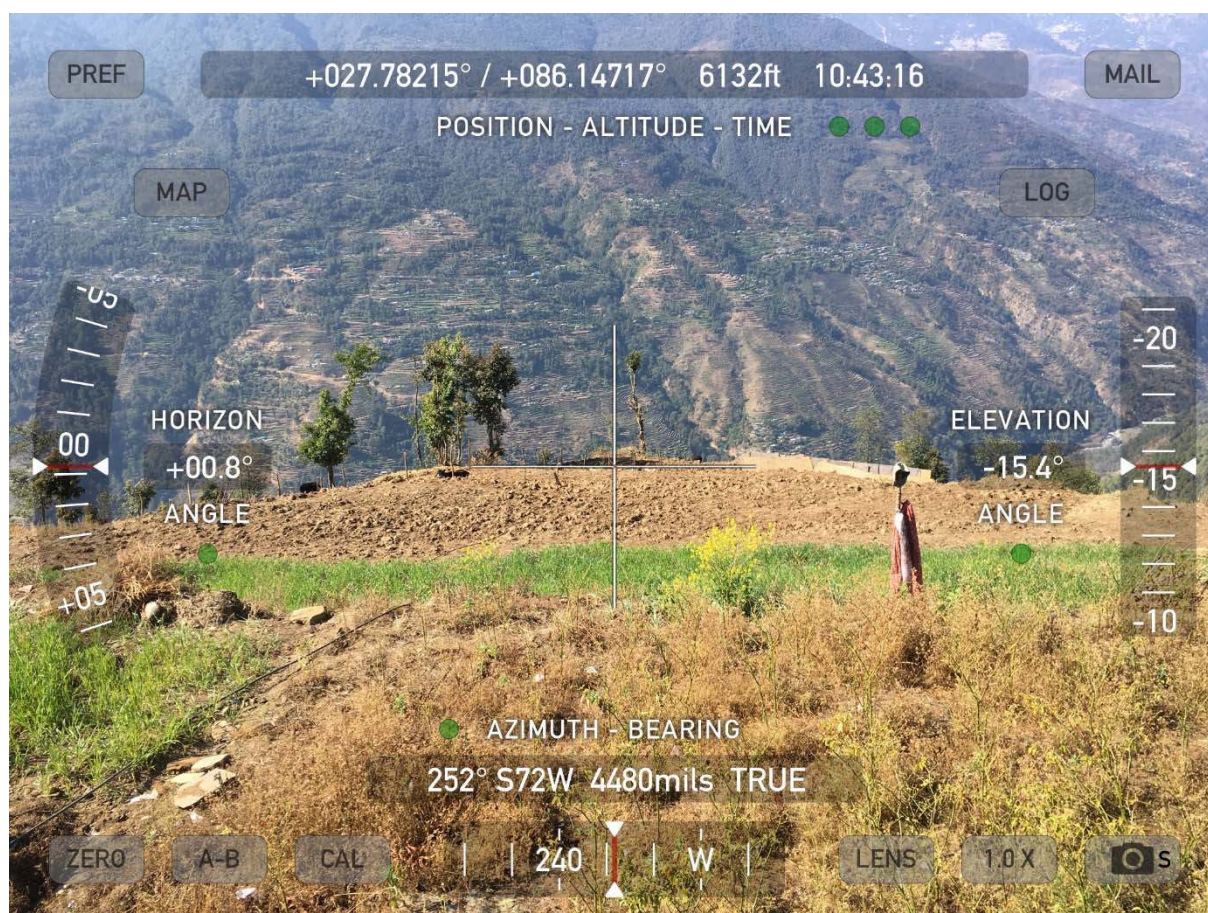
Figure 2-4 The average slope directly downside existing plot is about 15 degrees. The slope increases to the right side.

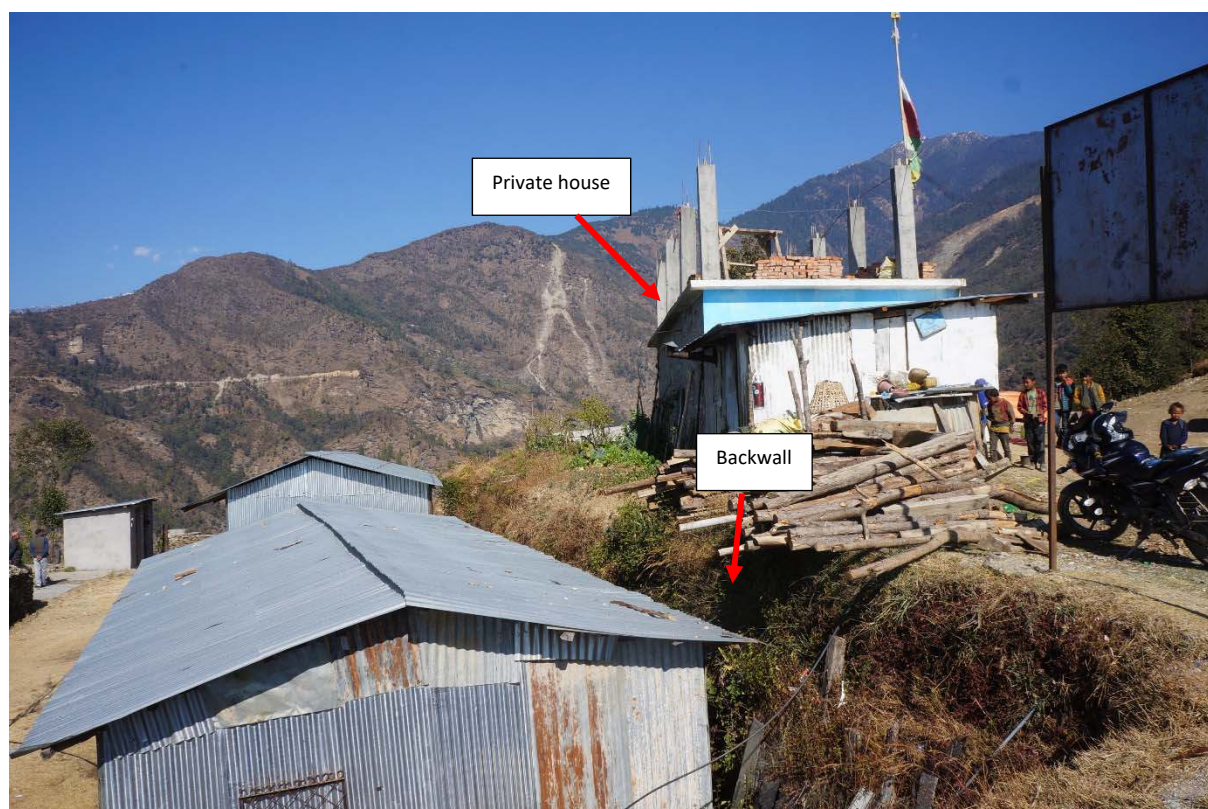
Figure 2-5 Slope behind the school and private house. The road has a sharp bend to the right.

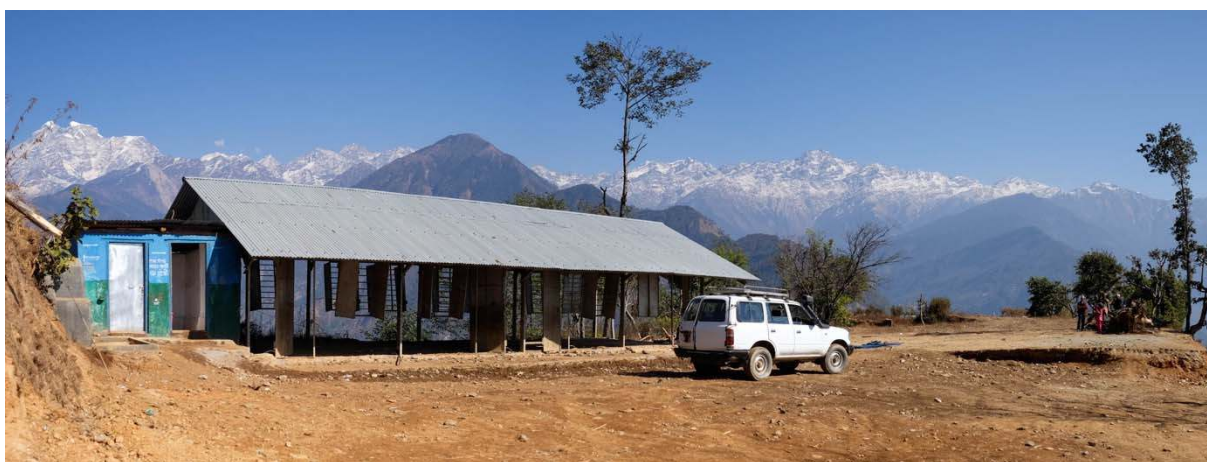
Figure 3-2 Gyalsung school plot. Looking north-east.

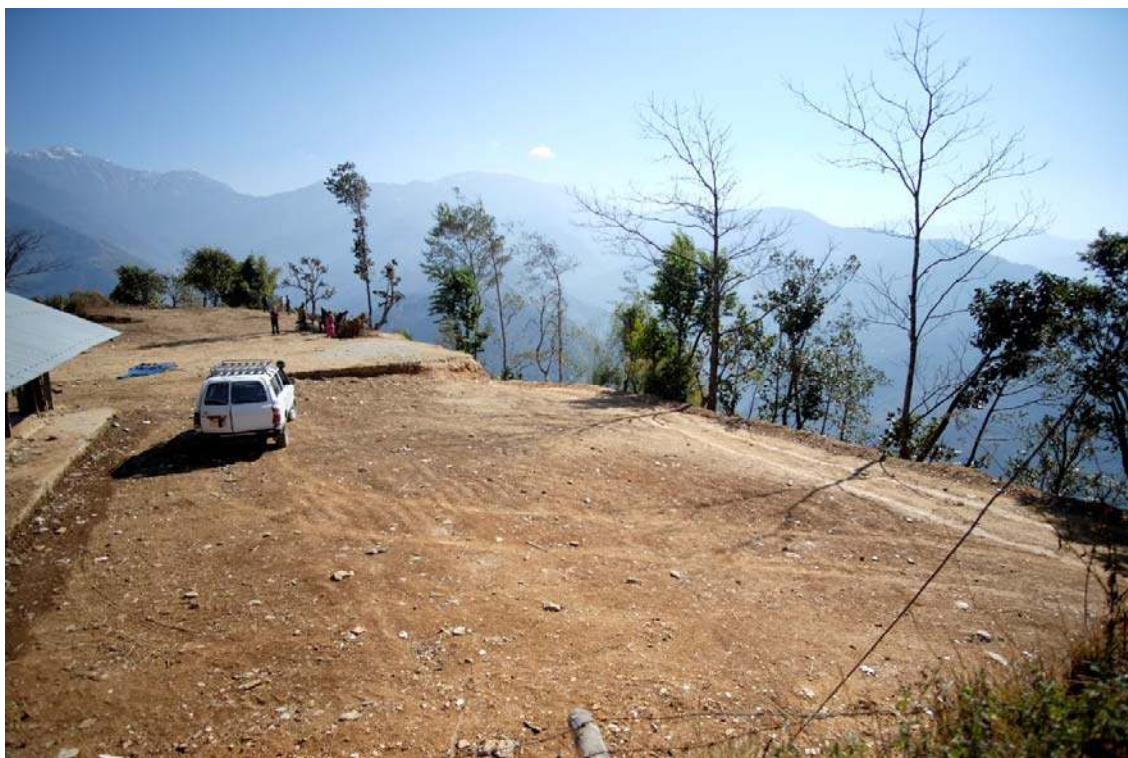
Figure 3-5 A new road is built or enlarged south of the plot. The second building will be placed left of this road, the third probably in the front between the buildings. There will be some room for a schoolyard between the buildings.

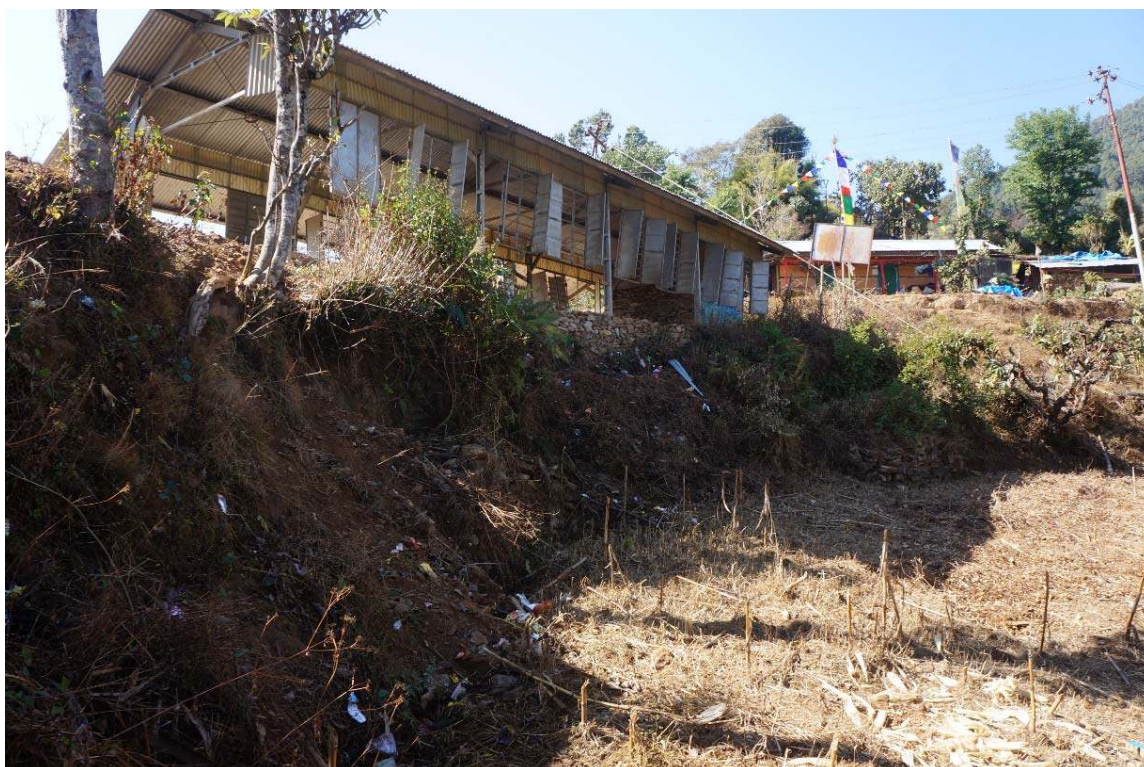
Figure 3-6 Northern side of the "building".

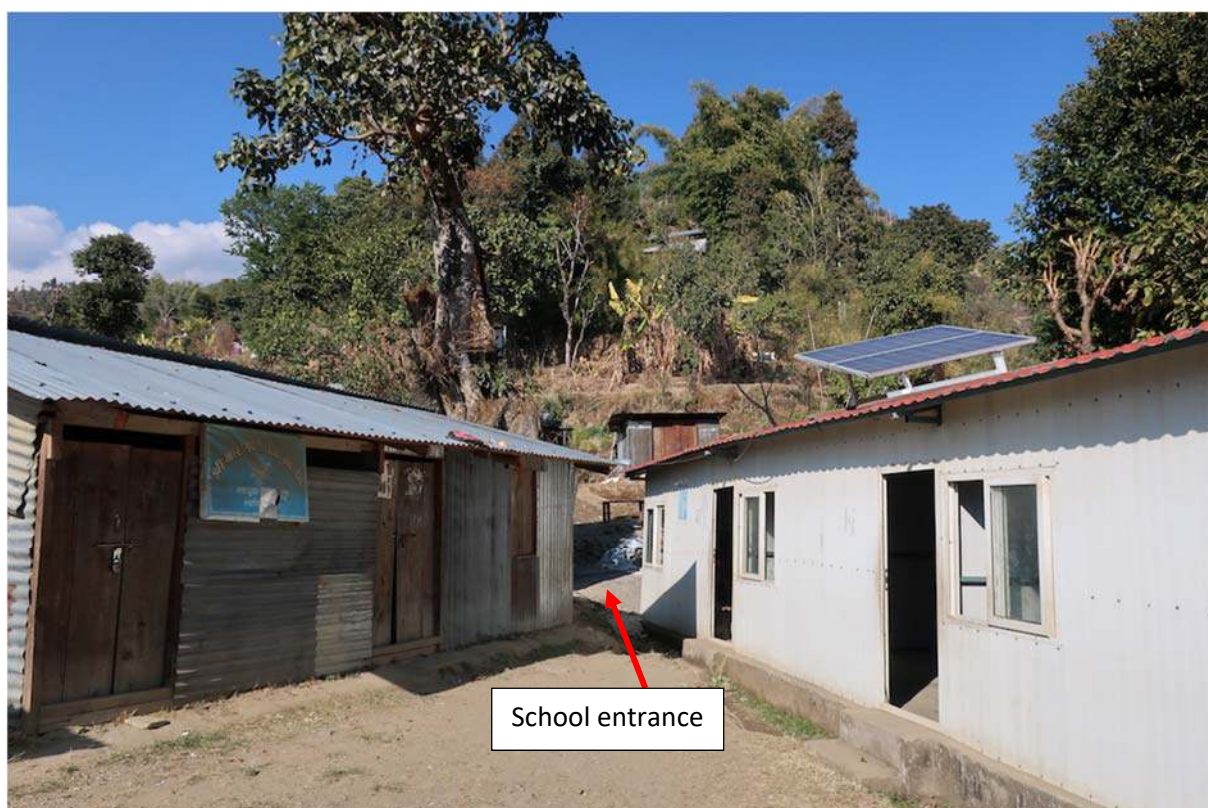
Figure 4-3 Narayani school. Entrance to the school between the buildings.

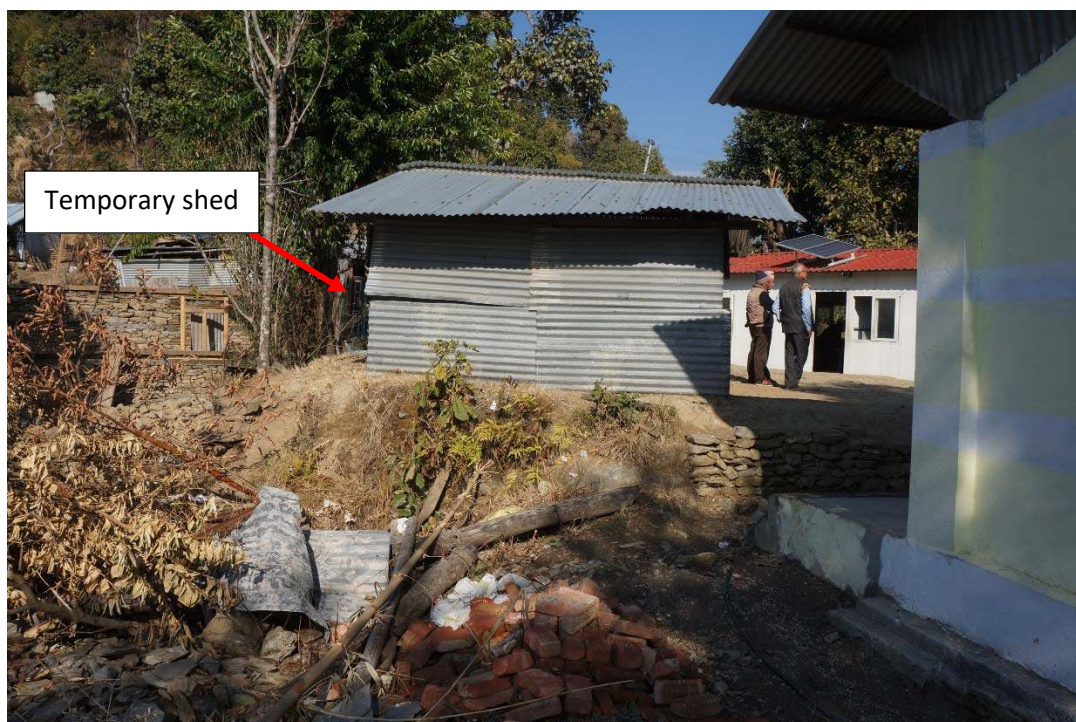
Figure 4-4 New 3-room building to be constructed in the place of the building centre. The triangular schoolyard to the right of the temporary sheds.

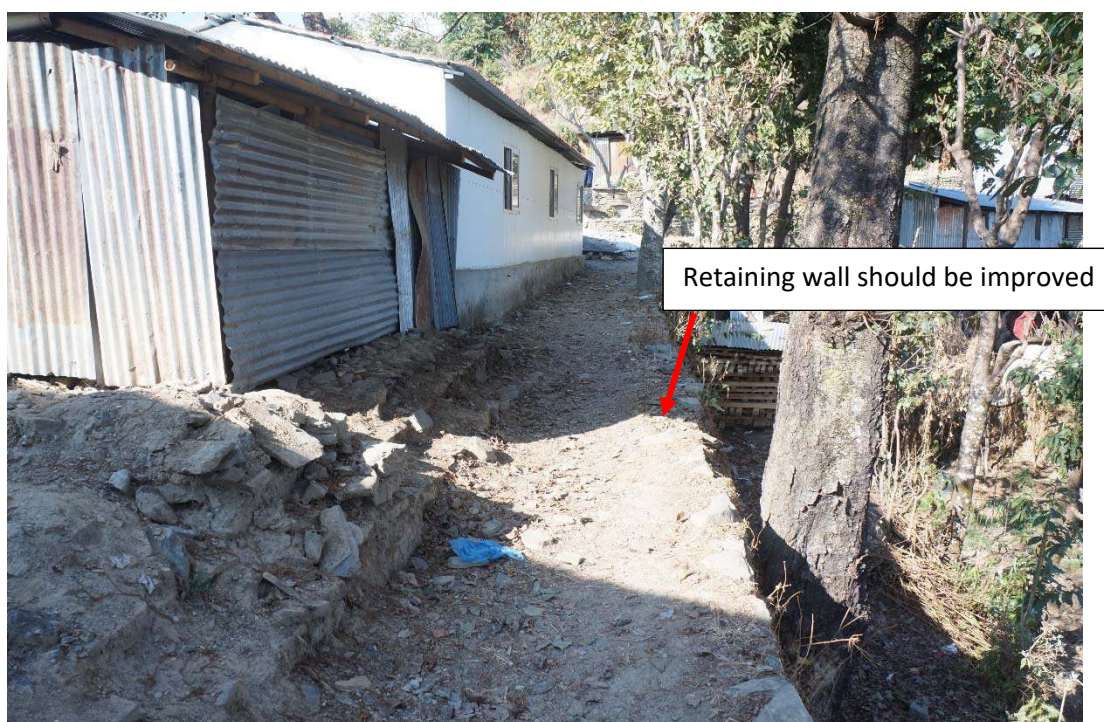
Figure 4-5 East side of the plot.

A retaining wall should be constructed on the east side of the plot. This should be in place before the foundation work of the new 3-room is started, to prevent damaging settlements.

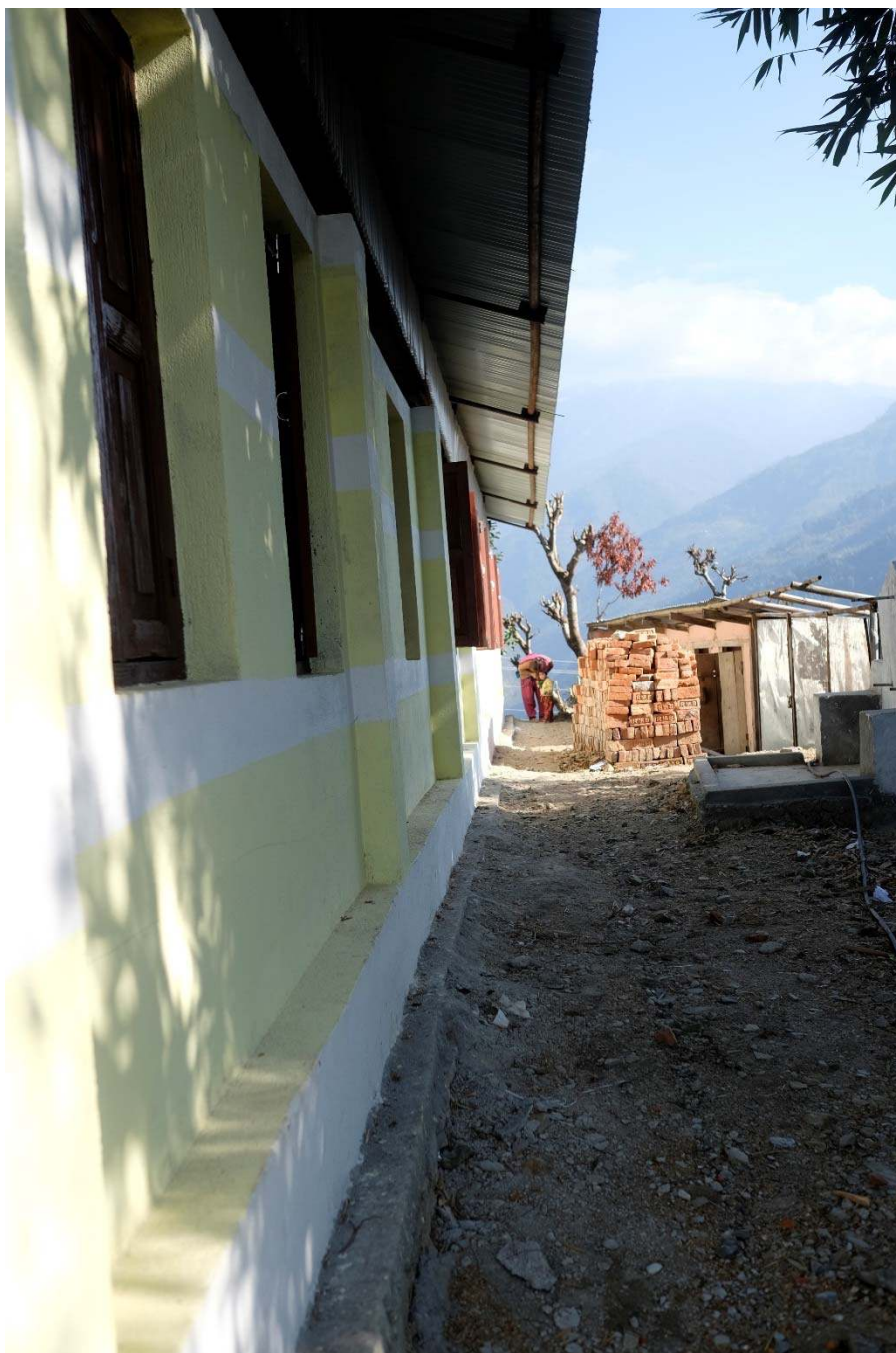
Figure 4-6 South side (downside) of newly constructed 3-room building.

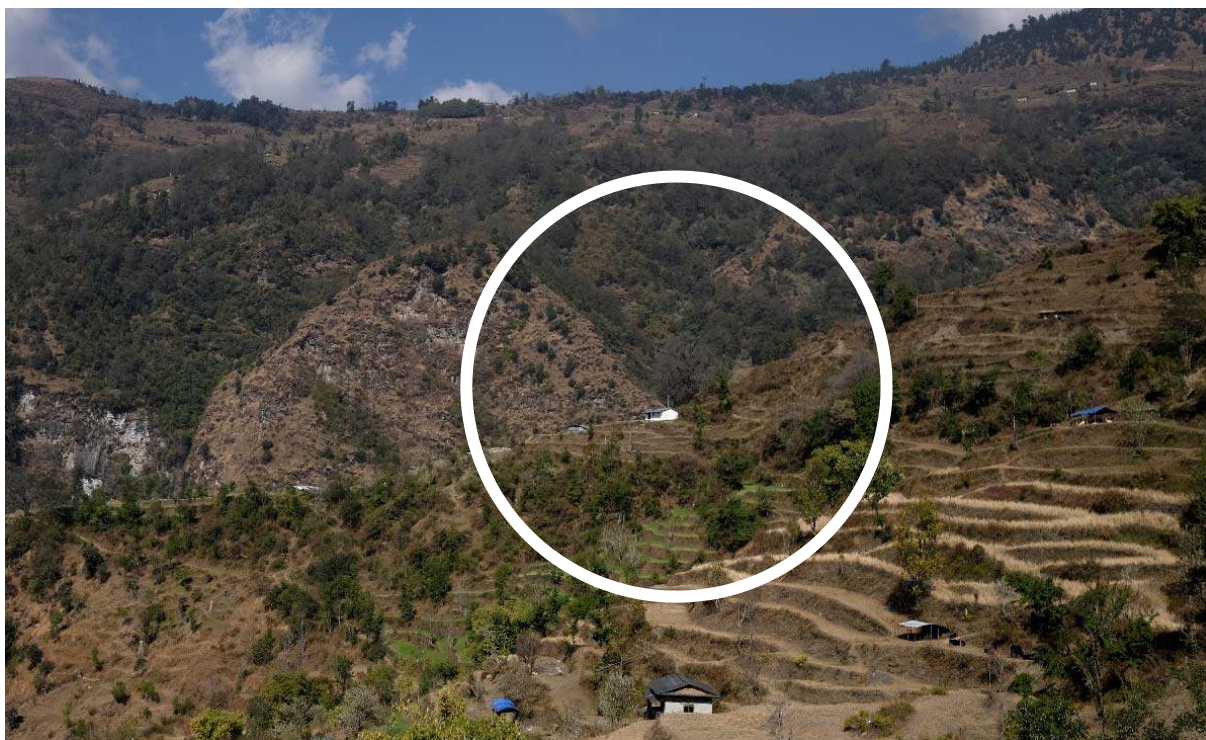
Figure 5-1 Kaileswori is situated on a ridge with a steep slope south of the plot. The white house is the staff building; the new school will be placed at the position of the grey building below. The entrance is from the road above the school.

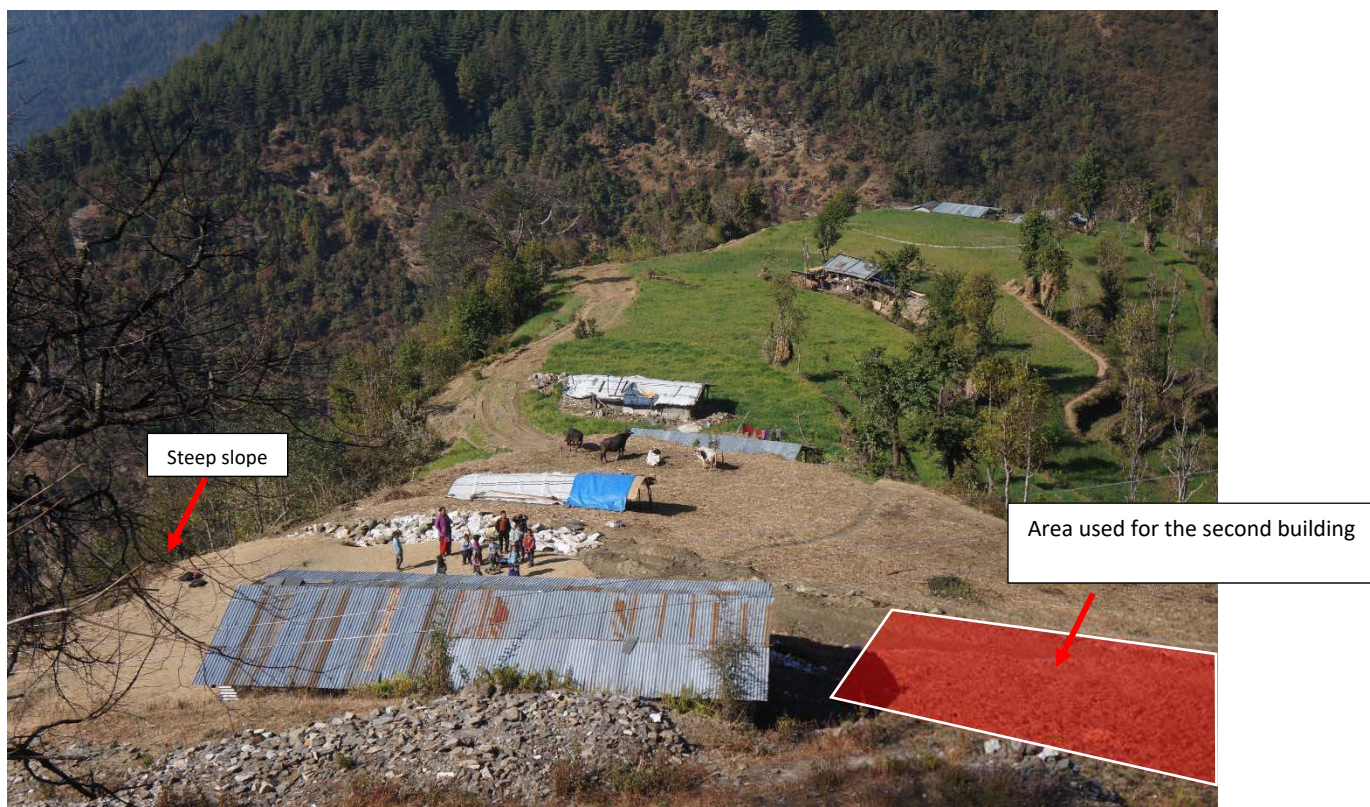
Figure 5-2 Steep slope at left side. The farmland to the right will be used for the second building.

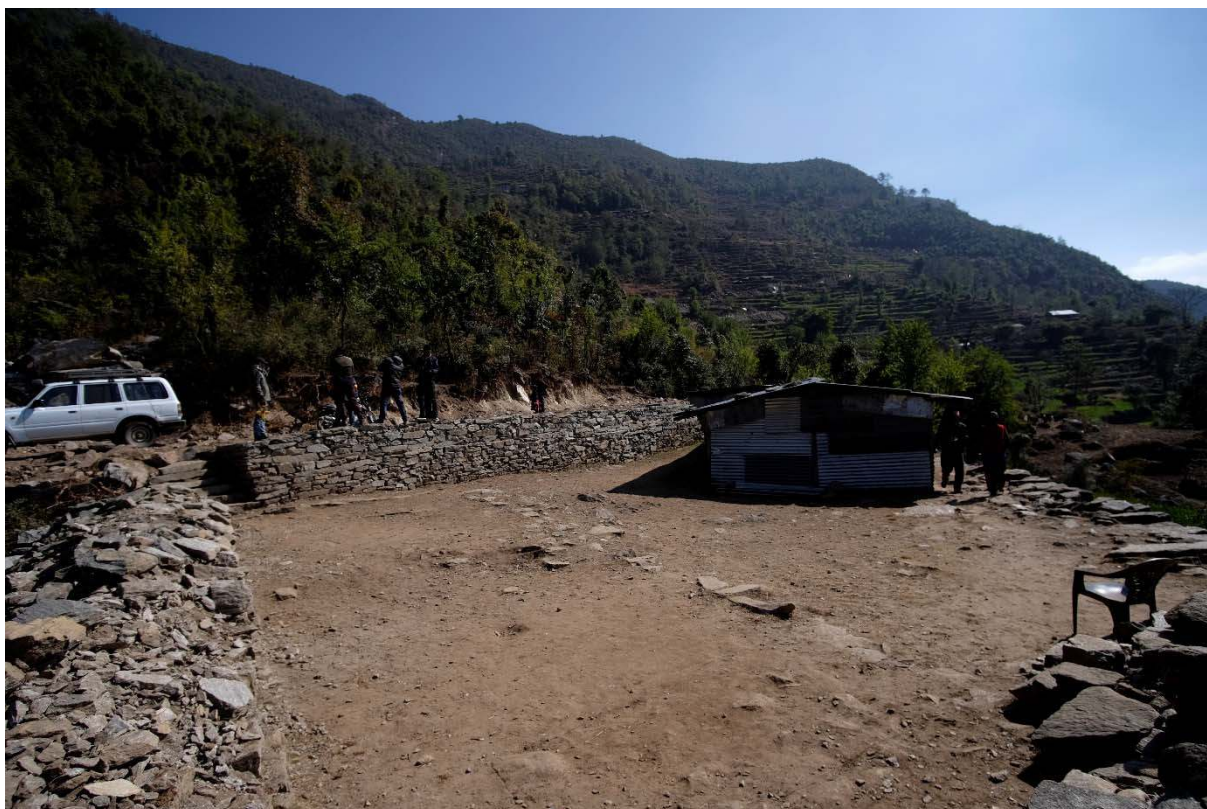
Figure 6-4 The lower level with the temporary building. Two buildings will be placed at the higher level, preferably in the inner part of the excavated area.

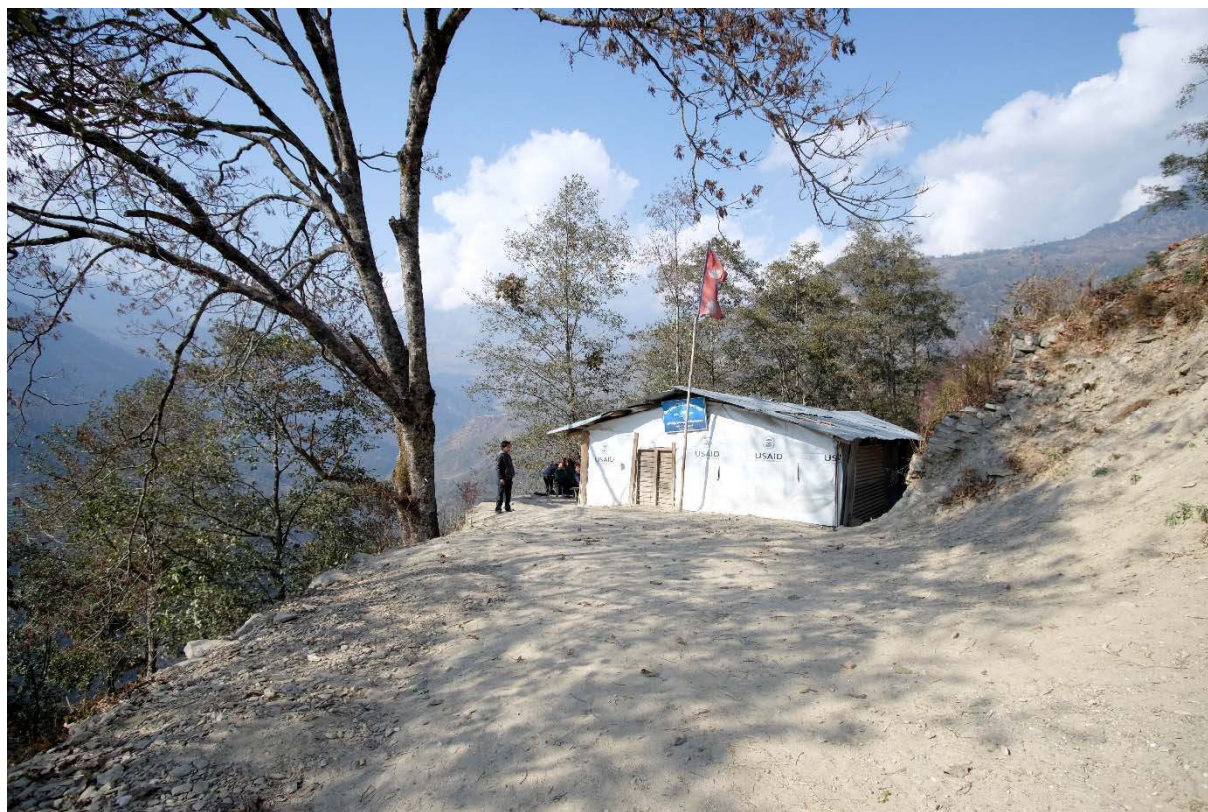
Figure 7-1 A small open place (schoolyard) south of the temporary building.

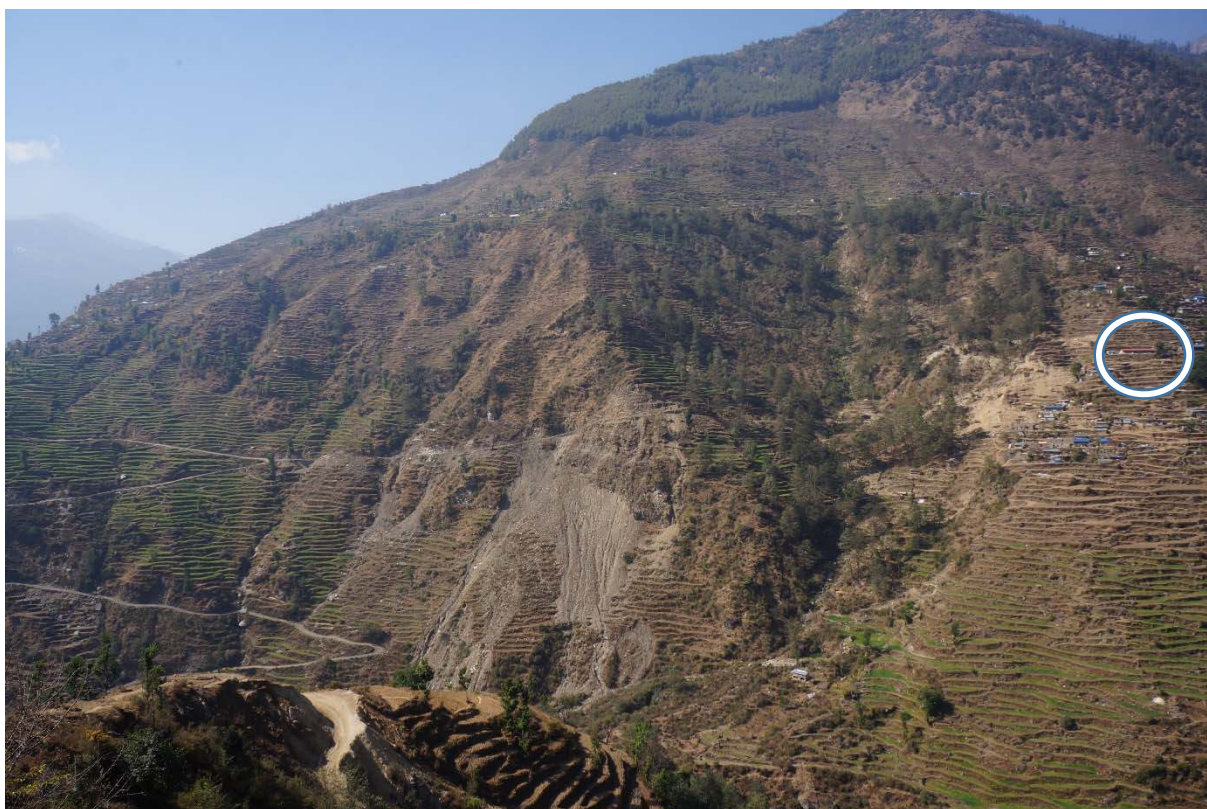
Figure 9-1 Photo from the ridge at Himali Devi towards Jana school and the access road from south. The new climbing road left of Jana is visible. Following drainage patterns from the hillside above, we see that the road cross these patterns, but the school is outside.

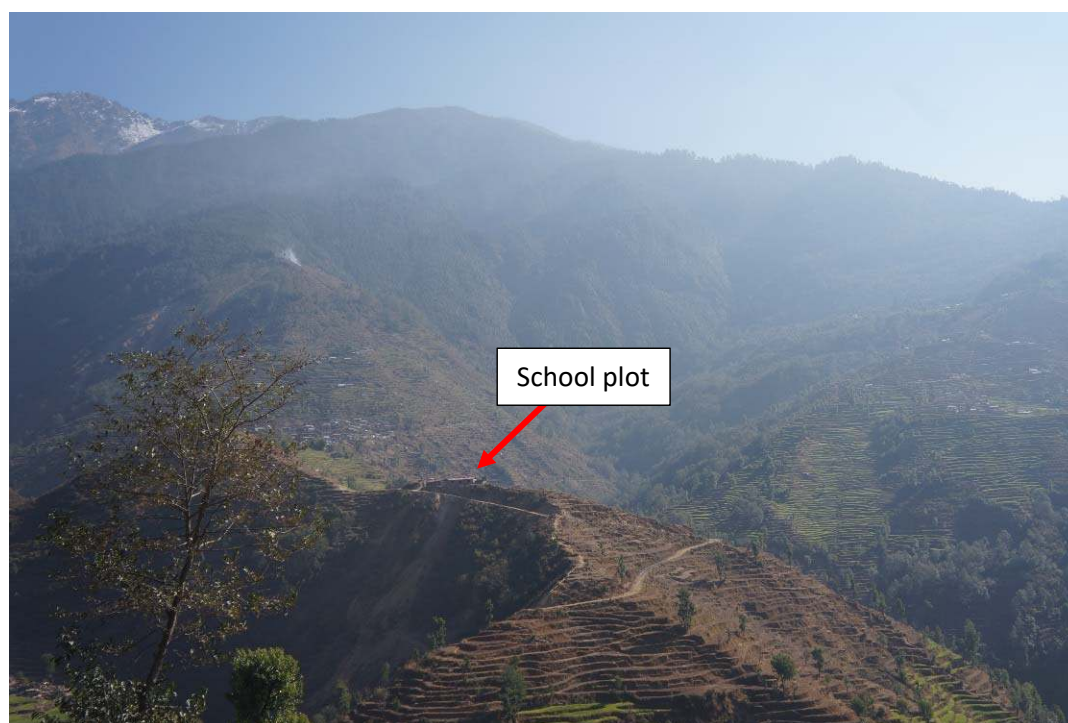
Figure 10-2 Himali Devi Primary school situated on the top of a slope, east of Syakhu River.

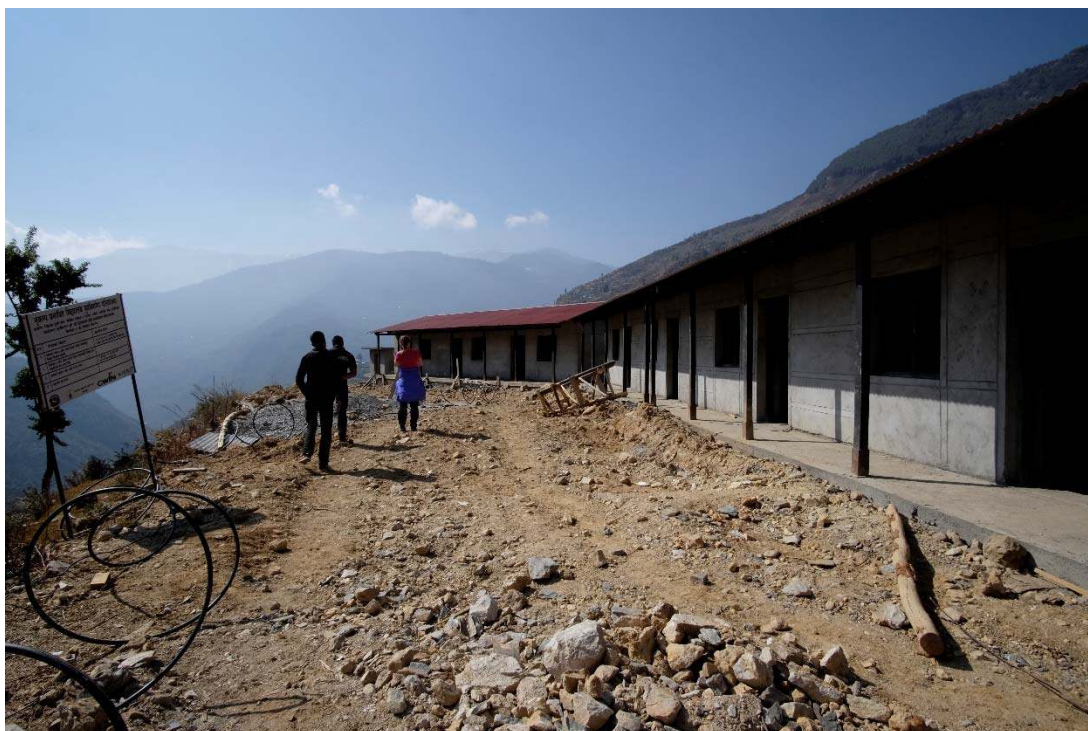
Figure 10-3 Looking south-east. Front of school, mainly in eastern direction.

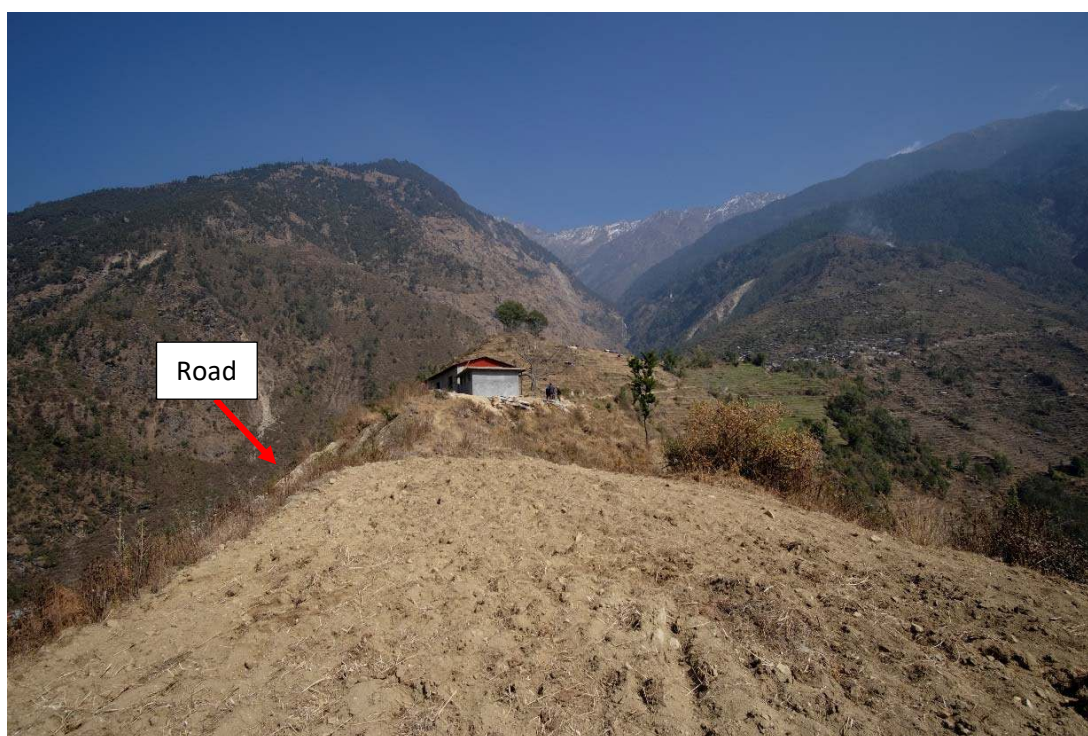
Figure 10-4 Looking north. The southern and eastern land (not visible) are arable land, the road visible at left side.

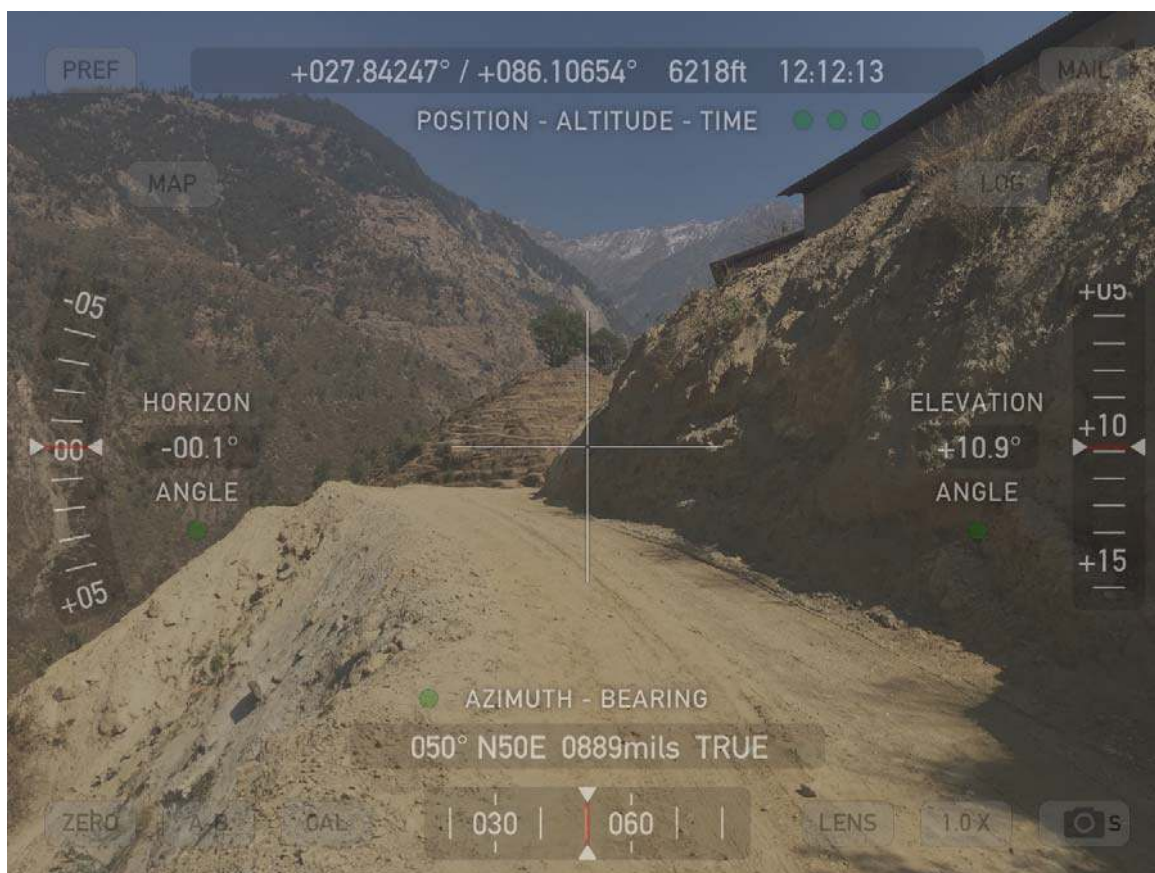
Figure 10-6 Road cut below the school, looking north.
